Stinson 108
Service Bulletin #267

March 31, 1950

Subject: Fuel Seepage Into Cabin

To: All Owners of Piper Stinson Model 108, 108-1, 108-2 and
108-3 Airplanes

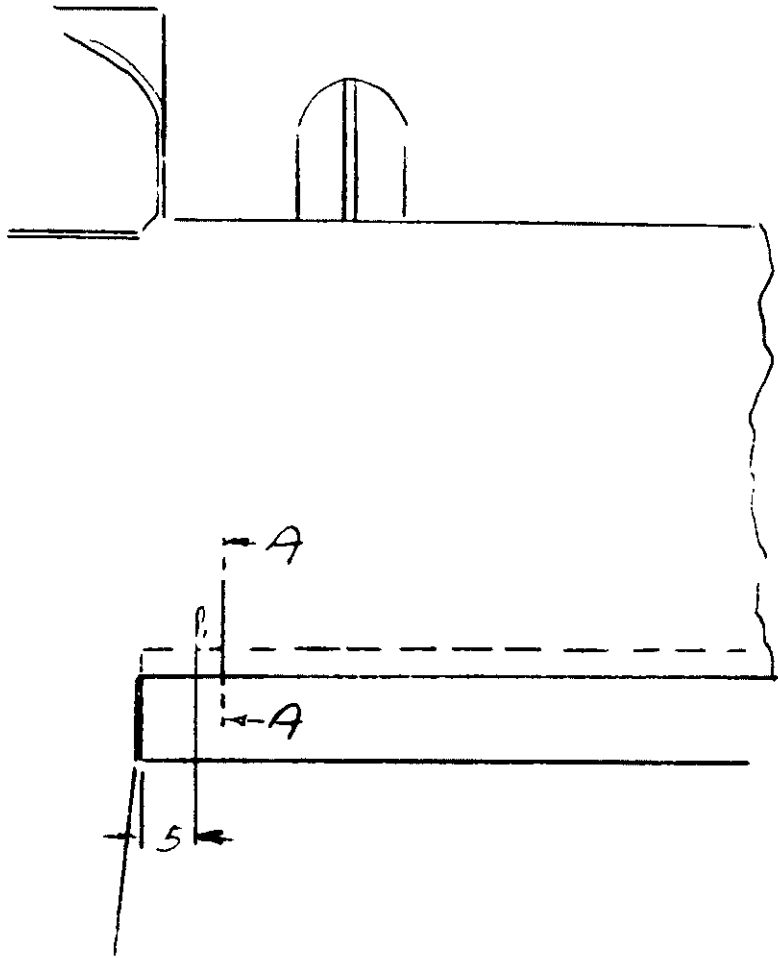
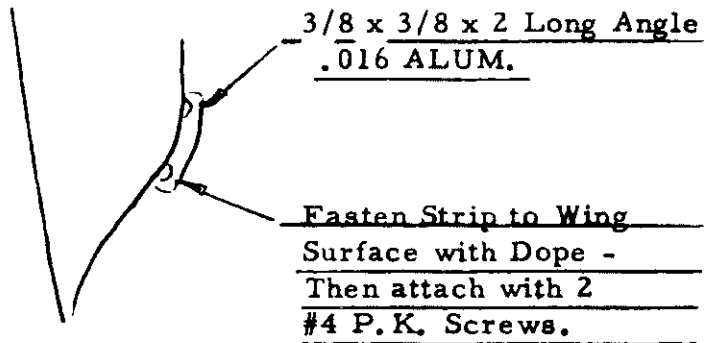
SECTION A - A

It has been noted that fuel overflow from the wing tanks tends to run towards the fuselage, creating the possibility of fuel seepage into the cabin.

Fuel overflow runs to the under surface of the wing, adhering to the lower radius of the trailing edge of the wing ribs over the flap span. Due to wing dihedral, the fuel then runs to the fuselage and down across the window.

It is recommended that a drip strip similar to that shown in the sketch on opposite side, be applied to the under surface of the wing.

Any suitable strip may be applied in the location shown that will break adhesion of the fuel to the wing panel.
