# SERVICE LETTER

## SERVICE INFORMATION LETTER NO. 78 SUBJECT: FUEL CAP ORIENTATION

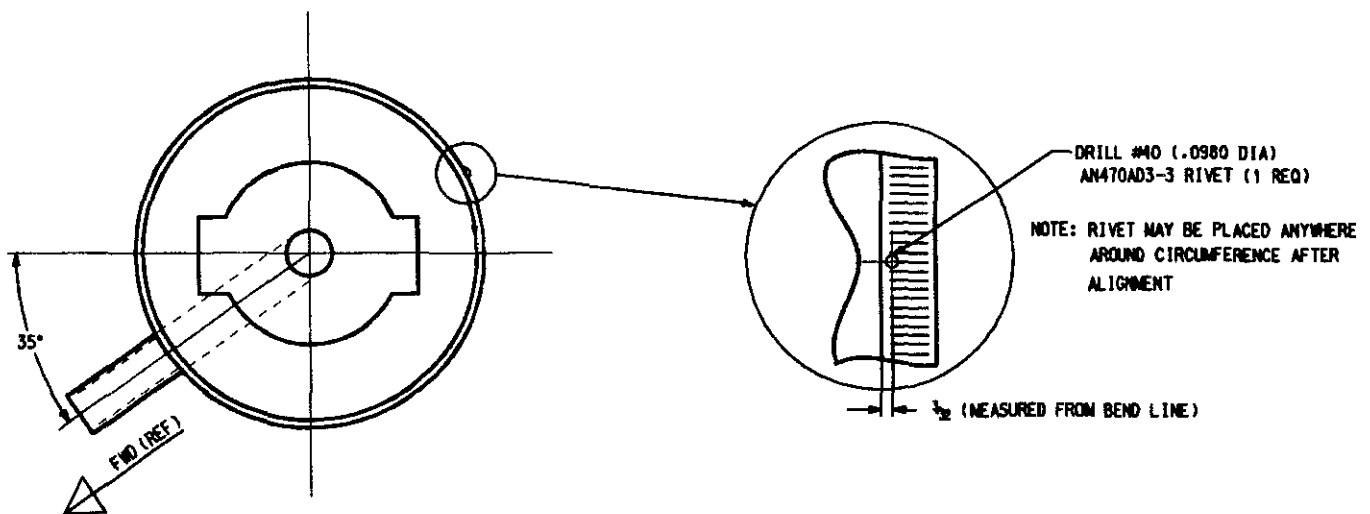
ILLUSTRATION A (VIEWED FROM BOTTOM OF CAP)

It has come to our attention that an unsafe condition may be created if the vent tube of P/N 108-1121111, fuel cap assembly, is not pointed directly into the oncoming air. Examination of these parts has revealed that the inner cap assembly may rotate with respect to the outer cap assembly, thereby producing the unsafe condition mentioned above.

1. Remove both wing tank fuel cap assemblies.
2. Check orientation of inner cap assembly and vent tube (see Illustration A). Move inner cap assembly to obtain correct orientation with vent tube. The inner cap assembly should be difficult to move and the vent tube should point directly forward when installed.
3. Drill #40 (.0980 dia.) through the inner and outer cap assemblies (see Illustration B). Install an AN470AD3-3 rivet to prevent the assemblies from becoming misaligned.
