# UNIVAIR AIRCRAFT CORPORATION

### MANDATORY SERVICE BULLETIN

**UNIVAIR MANDATORY SERVICE BULLETIN P-1**  
**DATED 8/10/2007**

Subject: Mandatory inspection of throttle casing (rigid sleeve) attachment to flexible housing. Compliance is mandatory prior to installation or within the next 5 hours of operation.

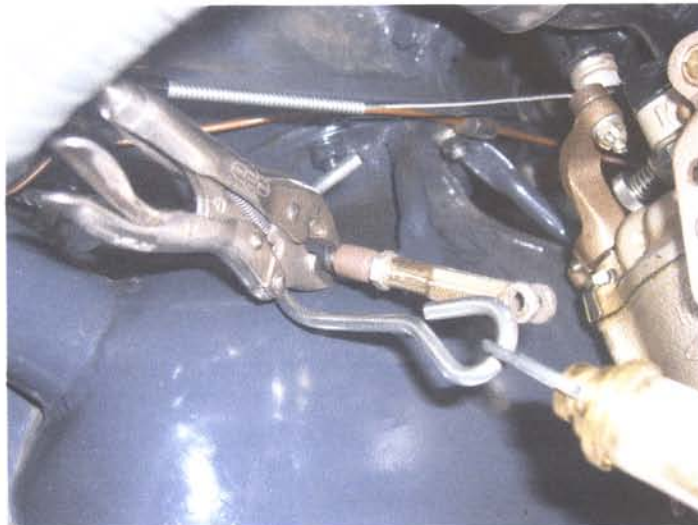
**Figure 1. Note rubber around throttle casing.**

- Protect the shaft of the cable guide with rubber, vinyl or duct tape.
- Grip shaft with small locking pliers near the outer end before the flare. Adjust pliers to lightly grip the shaft and allow the edge of pliers to slide to the base of the flare. **USE CAUTION** not to deform or scratch throttle casing.

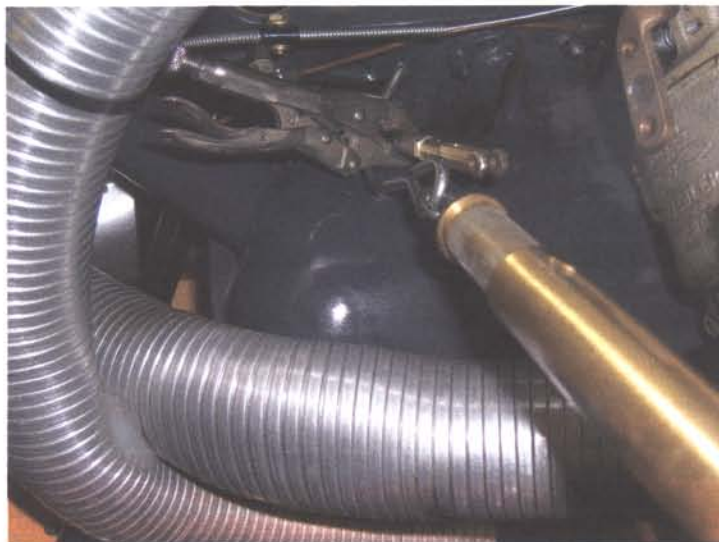
**Figure 2. Scale pulling in line with cable.**

- Once pliers are attached, pull against pliers with a spring scale. **USE CAUTION** to keep pull as close to the center line of the cable as possible.

- Pull until scale reads 35-40 pounds.
