MANDATORY SERVICE BULLETIN P-2

LANDING GEAR HYDRASORB INSPECTION

SUBJECT: Inspection of landing gear hydrasorb shock struts.

MODELS AFFECTED: Piper PA-25-235 and Piper PA-25-260 Pawnee aircraft with Univair hydrasorb shock struts p/n U486-604-1 as used on the Univair U64052-002 and U64052-003 shock strut assemblies.

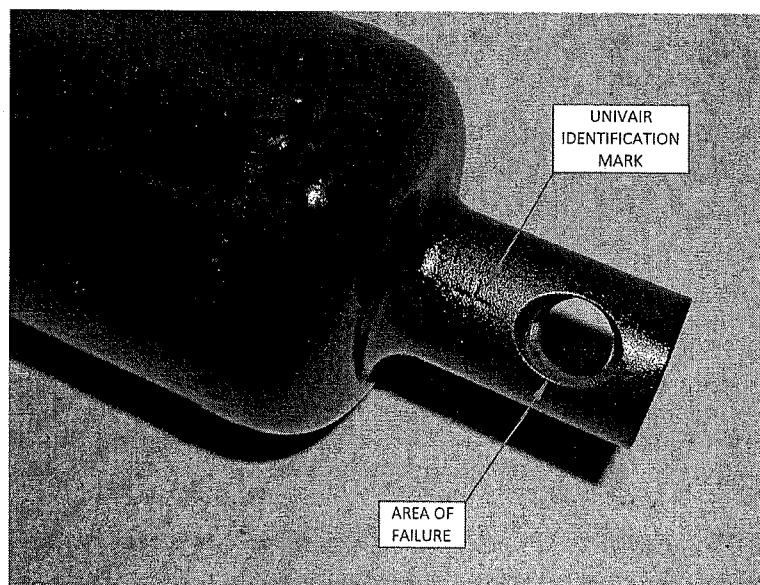
Figure 1

Failure was comprised of a fatigue crack that propagated from the edge of the bolt hole, across a portion of the length of the hole until the end of the unit broke off. The initial crack appears to have developed over the course of time before final failure occurred.

Note: The hydrasorb that failed had an end fitting as in figure 1. Figure 2 is a hydrasorb with a newly designed end fitting.

5. If any hole elongation is found, or if any cracking is found, replace the U486-604-1 hydrasorb unit prior to re-installation of the U64052- series shock strut assembly.
6. Inspect attach hardware and elastic shock cords. Replace as necessary.
7. Installation of the shock strut assembly is the opposite of the removal.
8. Repeat procedures 1 through 7 for the other landing gear.
