ALUMINUM RIB Service Letter No. 100 Field Repair Process

UNIVAIR AIRCRAFT CORPORATION Service Letter No. 100 Field Repair Process

SUBJECT: Stamped Rib Repair

MODELS AFFECTED: J-3, J-5C, PA-11, PA-12, PA-14, PA-15, PA-16, PA-17,

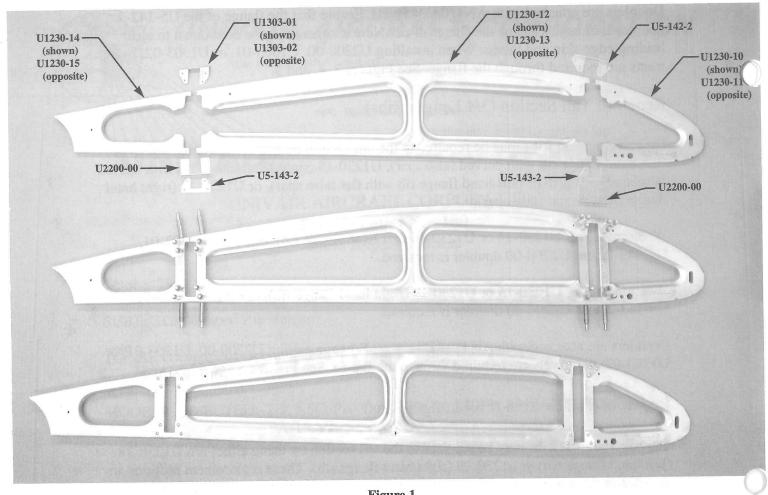
Figure 1

This letter outlines the repair of Univair STC'ed Stamped Ribs in accordance with the original STC and FAA Advisory Circular AC 43.13-1B. Repairable ribs include all full length ribs and 3/4 length ribs excluding tip ribs and nose ribs. See Figures 1 and 2.
