## **SPECIAL AIRWORTHINESS INFORMATION BULLETIN SAIB CE-14-03**

### **Inspection of Ercoupe Main Wing Spar for Inappropriate Modifications and/or Unapproved Holes**

## **SPECIAL AIRWORTHINESS INFORMATION BULLETIN**

**SAIB:** CE-14-03

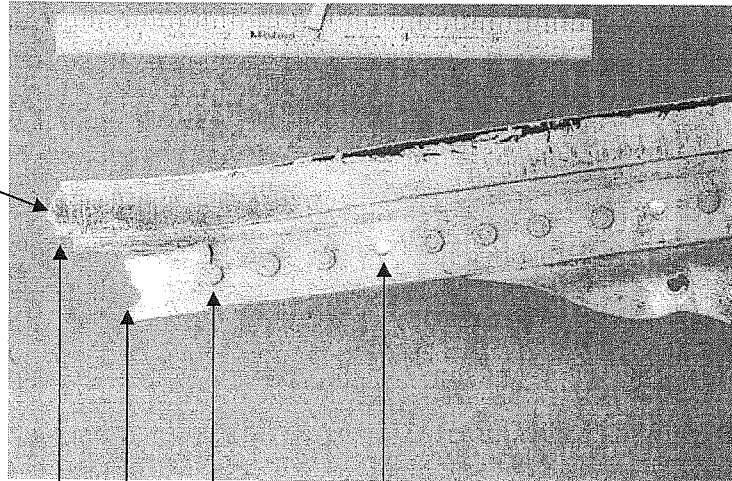
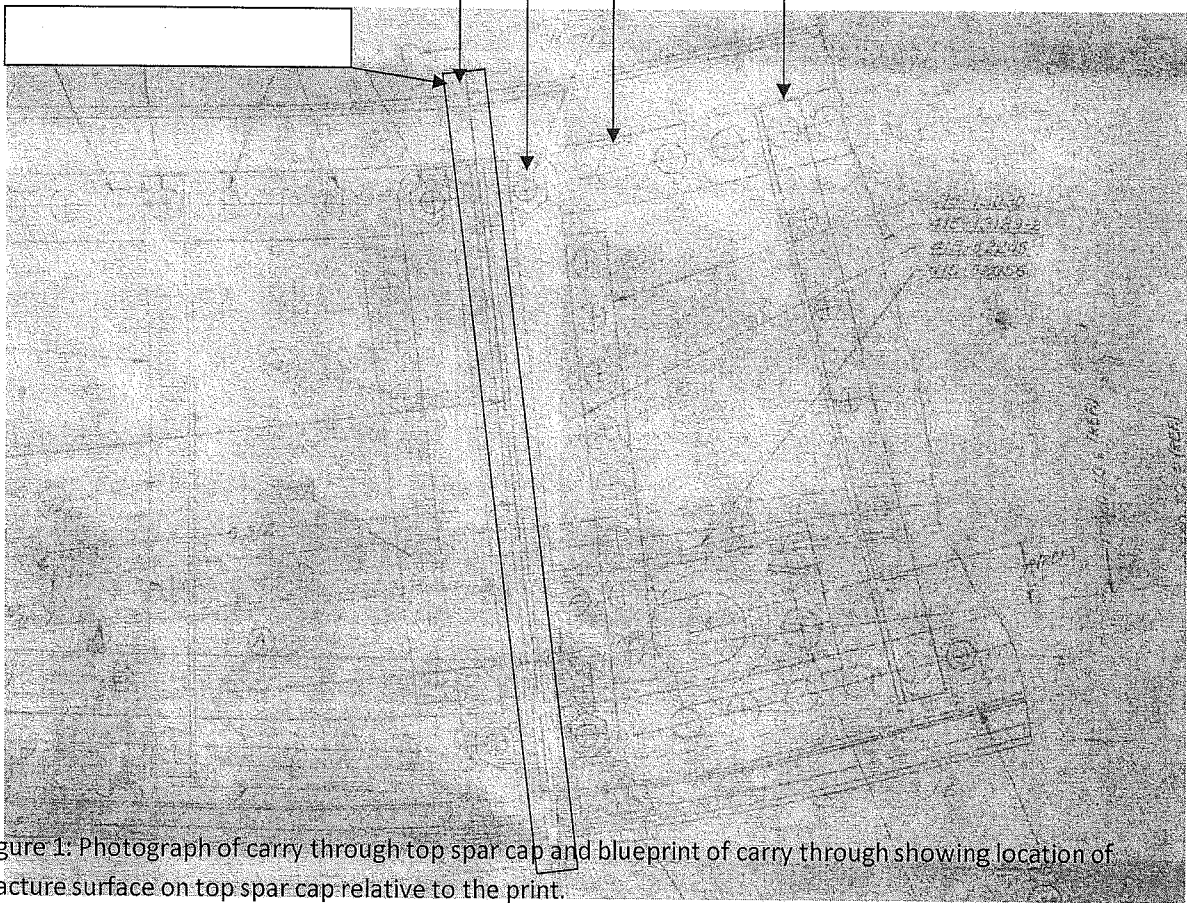
**Note:** See Figures 1 and 2 below for information of an example of an inappropriate modification performed on a spar cap. This particular spar cap most probably failed due to the pilot exceeding the design stress limitation of the airplane. A self-tapping fastener had broken off in one threaded hole and another had been threaded right into the radius of the flanged member of the spar cap (the "T" junction). The location of the hole in the spar cap T junction can lead to a reduction in structural strength of the affected structure.

Centerline of carry through. The three threaded screw holes are on this fracture surface.

Centerline of carry through.

Figure 1: Photograph of carry through top spar cap and blueprint of carry through showing location of fracture surface on top spar cap relative to the print.

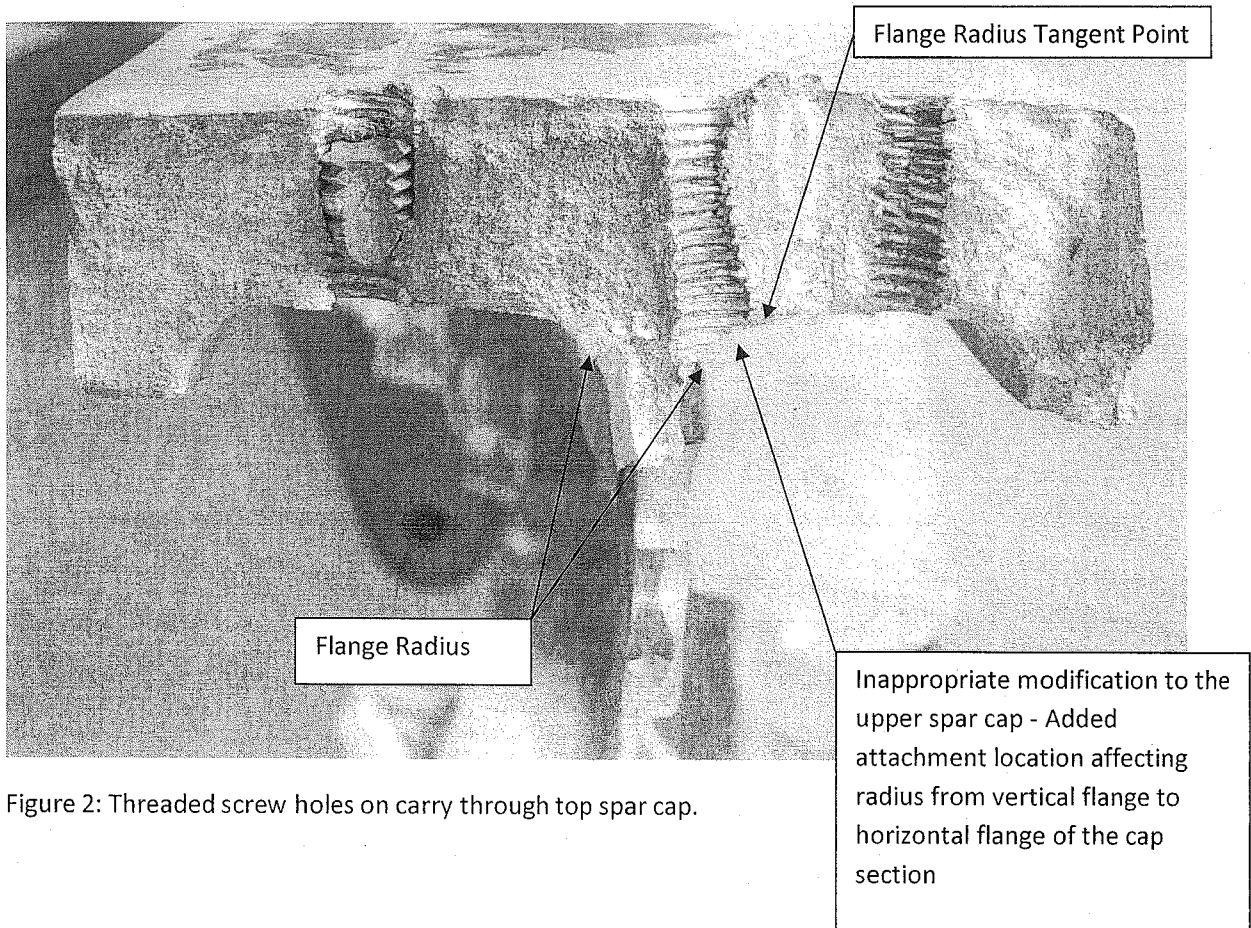
Figure 2: Threaded screw holes on carry through top spar cap.

- If during any inspection open holes are found to exist in the spar cap structure as shown in Figure 2, or in the spar web areas; fill the open hole locations using the following guidance documents: Advisory Circular (AC) 43.13-1B Section 4-57, Advisory Circular 43.13-2B, Chapter 1, Paragraphs 106-110, and Metallic Materials Properties Development and Standardization (MMPDS-04) April 2008, Chapter 8, Page 8-13. Monitor this repair under standard aircraft inspection intervals. If it is necessary to drill an open hole location to obtain a clean hole for rivet installation, the final hole diameter should not intersect the tangent point to the flange radius as shown in Figure 2. Avoid drilling holes larger than 10-percent of the existing cross sectional area; or otherwise decreasing the effective tensile strength areas and/or edge distance of wing spar cap strips, web areas, or highly stressed tensile areas. If these criteria cannot be satisfied, further repair as noted above will be necessary.
