REPAIR TO CENTER SECTION BUTT RIB (PART NO. 415-13131 L & R)
UPPER FRONT COR.

ENGINEERING ORDER

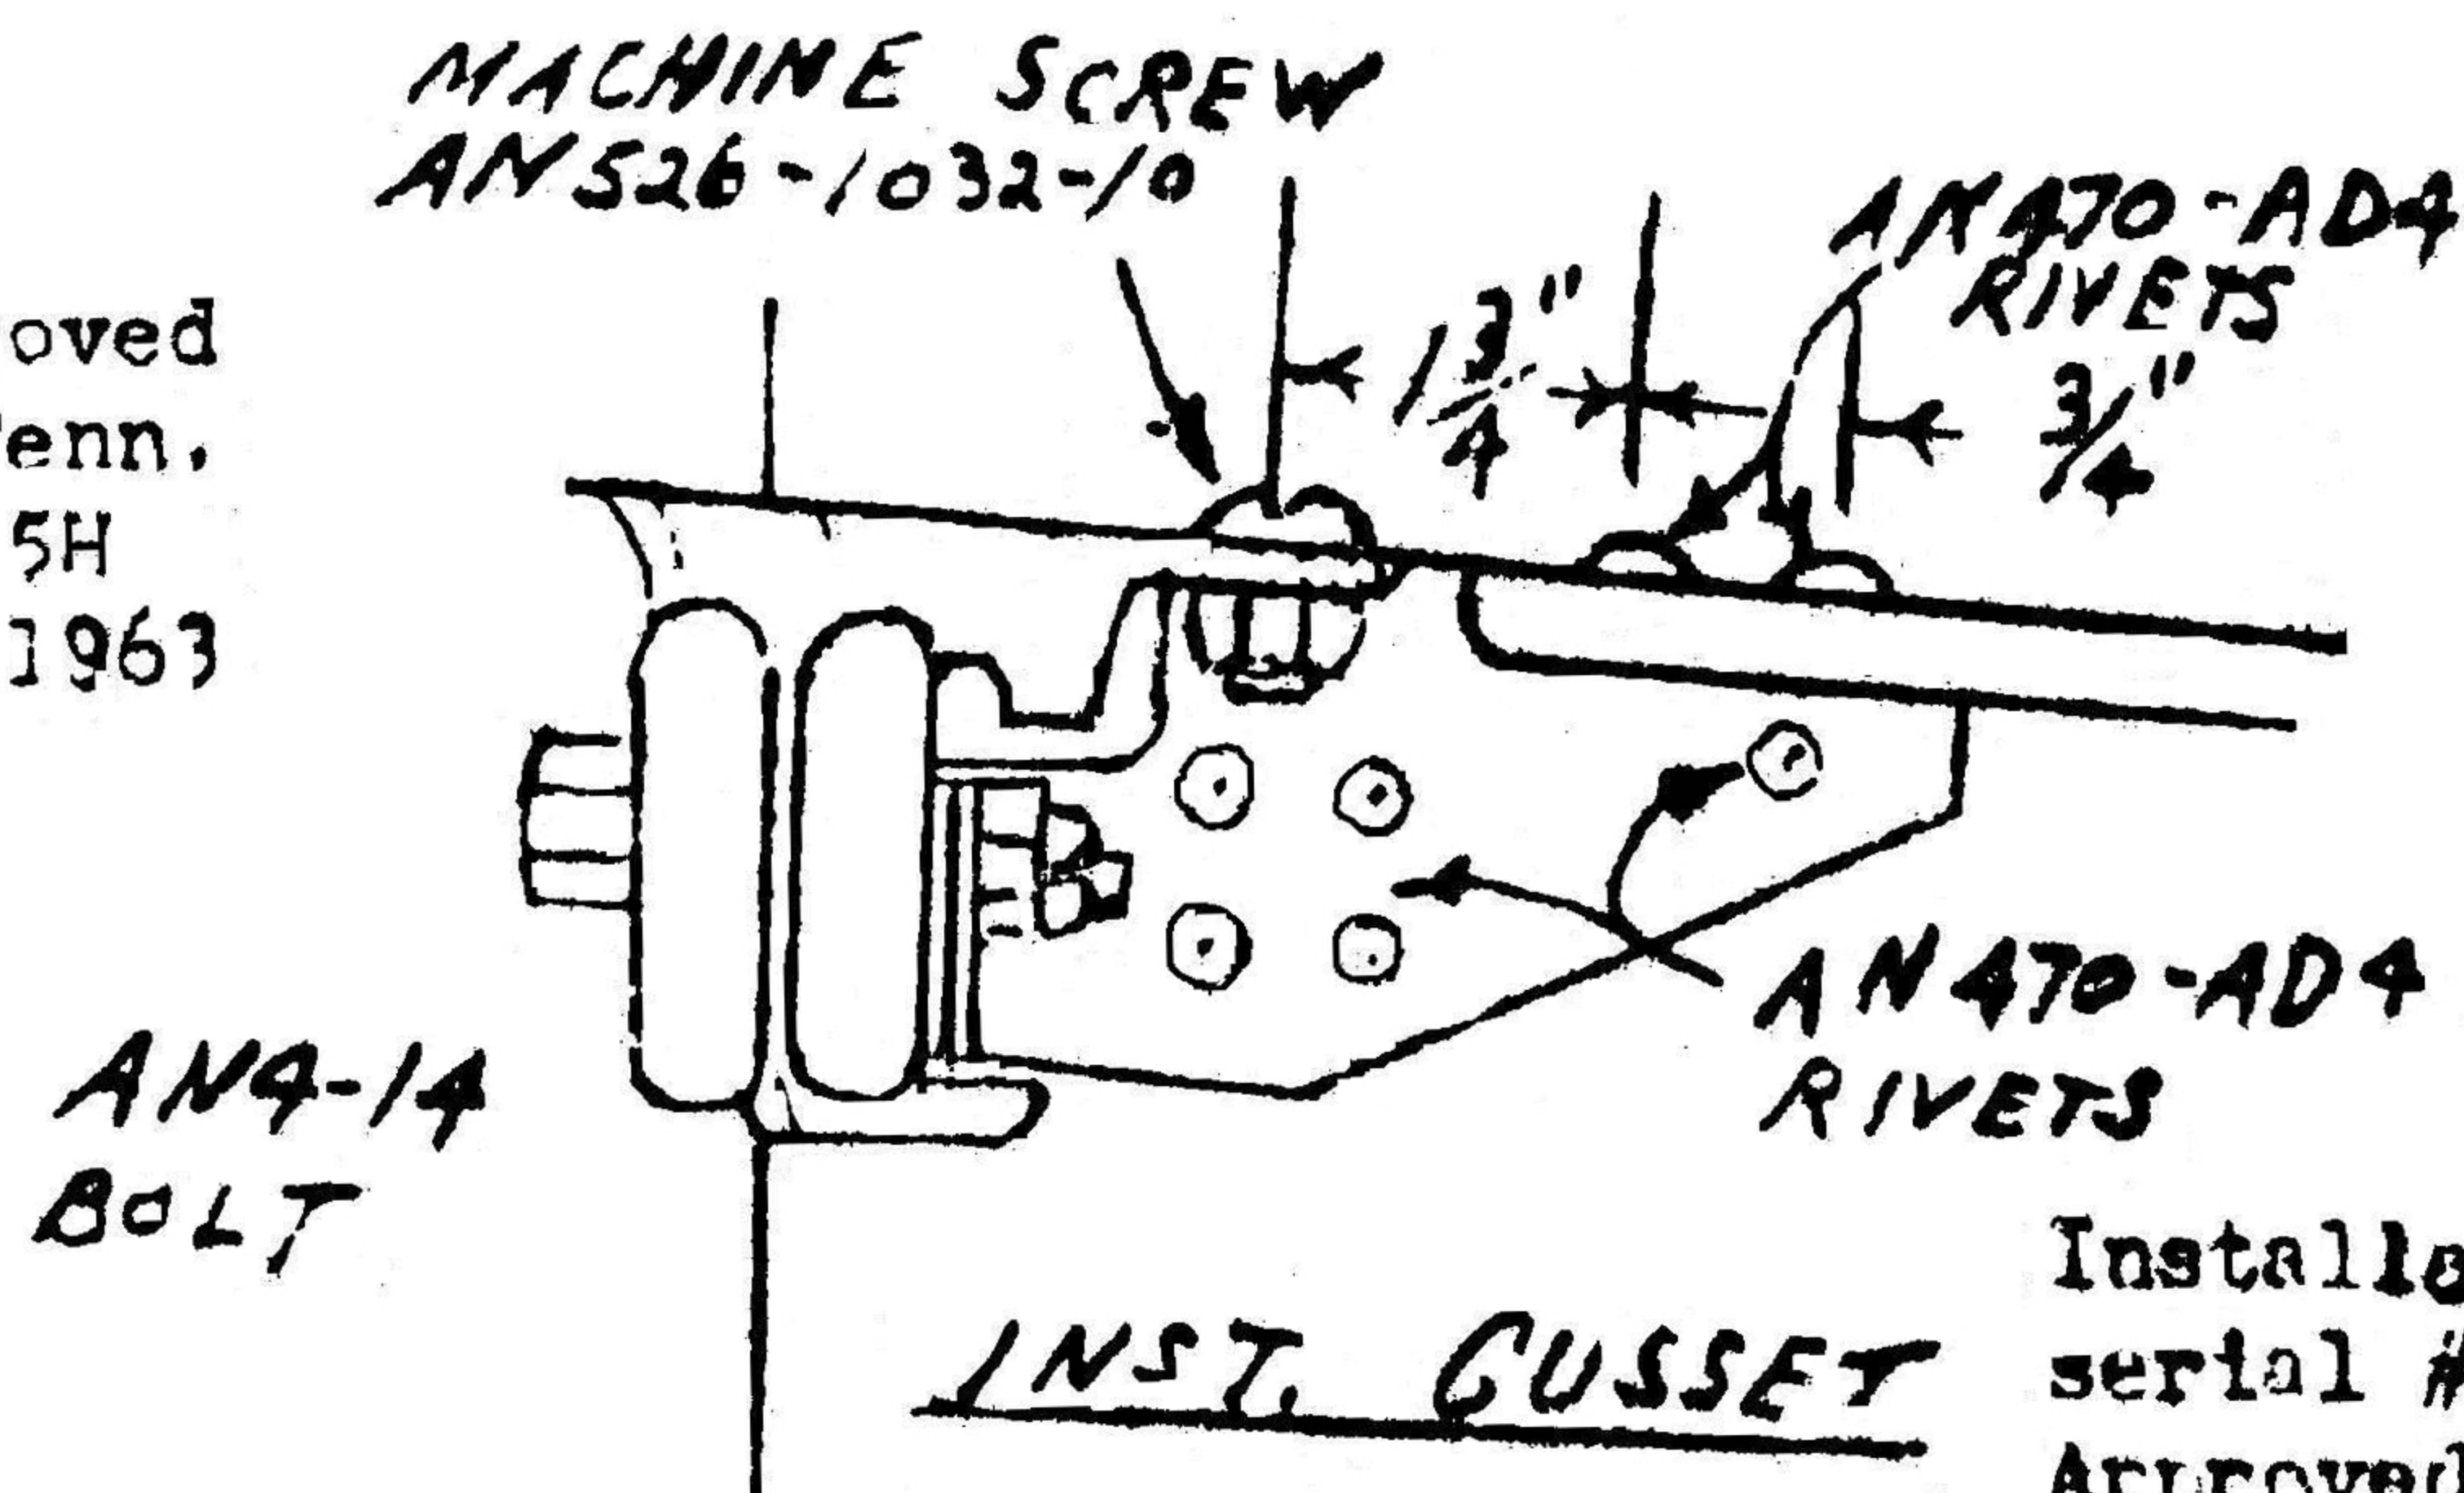
Installed on Ercoupe N2815H,
serial #3440, Oct. 11, 1963
Approved by
FAA Office, Harrisburg, Penn.

Stop drill the crack with #40 drill, remove the AN4-14 bolt and AN526-1032 machine screw. Clamp the gusset into place. Drill the hole to reinstall the AN4-14 bolt and AN525-1032 machine screw. Use #30 drill for the five (5) holes for the AN470-AD4 rivets to secure the gusset to the flange and gusset as shown on the drawing. Remove the gusset and remove all the drill chips. Wet zinc chromate the gusset and rib area. Replace the gusset and reinstall the AN4-14 bolt and secure with AN310-4 nut and key. Install the AN325-1032-10 machine screw, then secure with AN 960-10 washer and AN365-1032 nut. Rivet the gusset to the rib web with (5) five AN470-AD4 rivets. Then rivet the alum. shim rib flange and gusset with (2) two AN470-AD4 rivets.

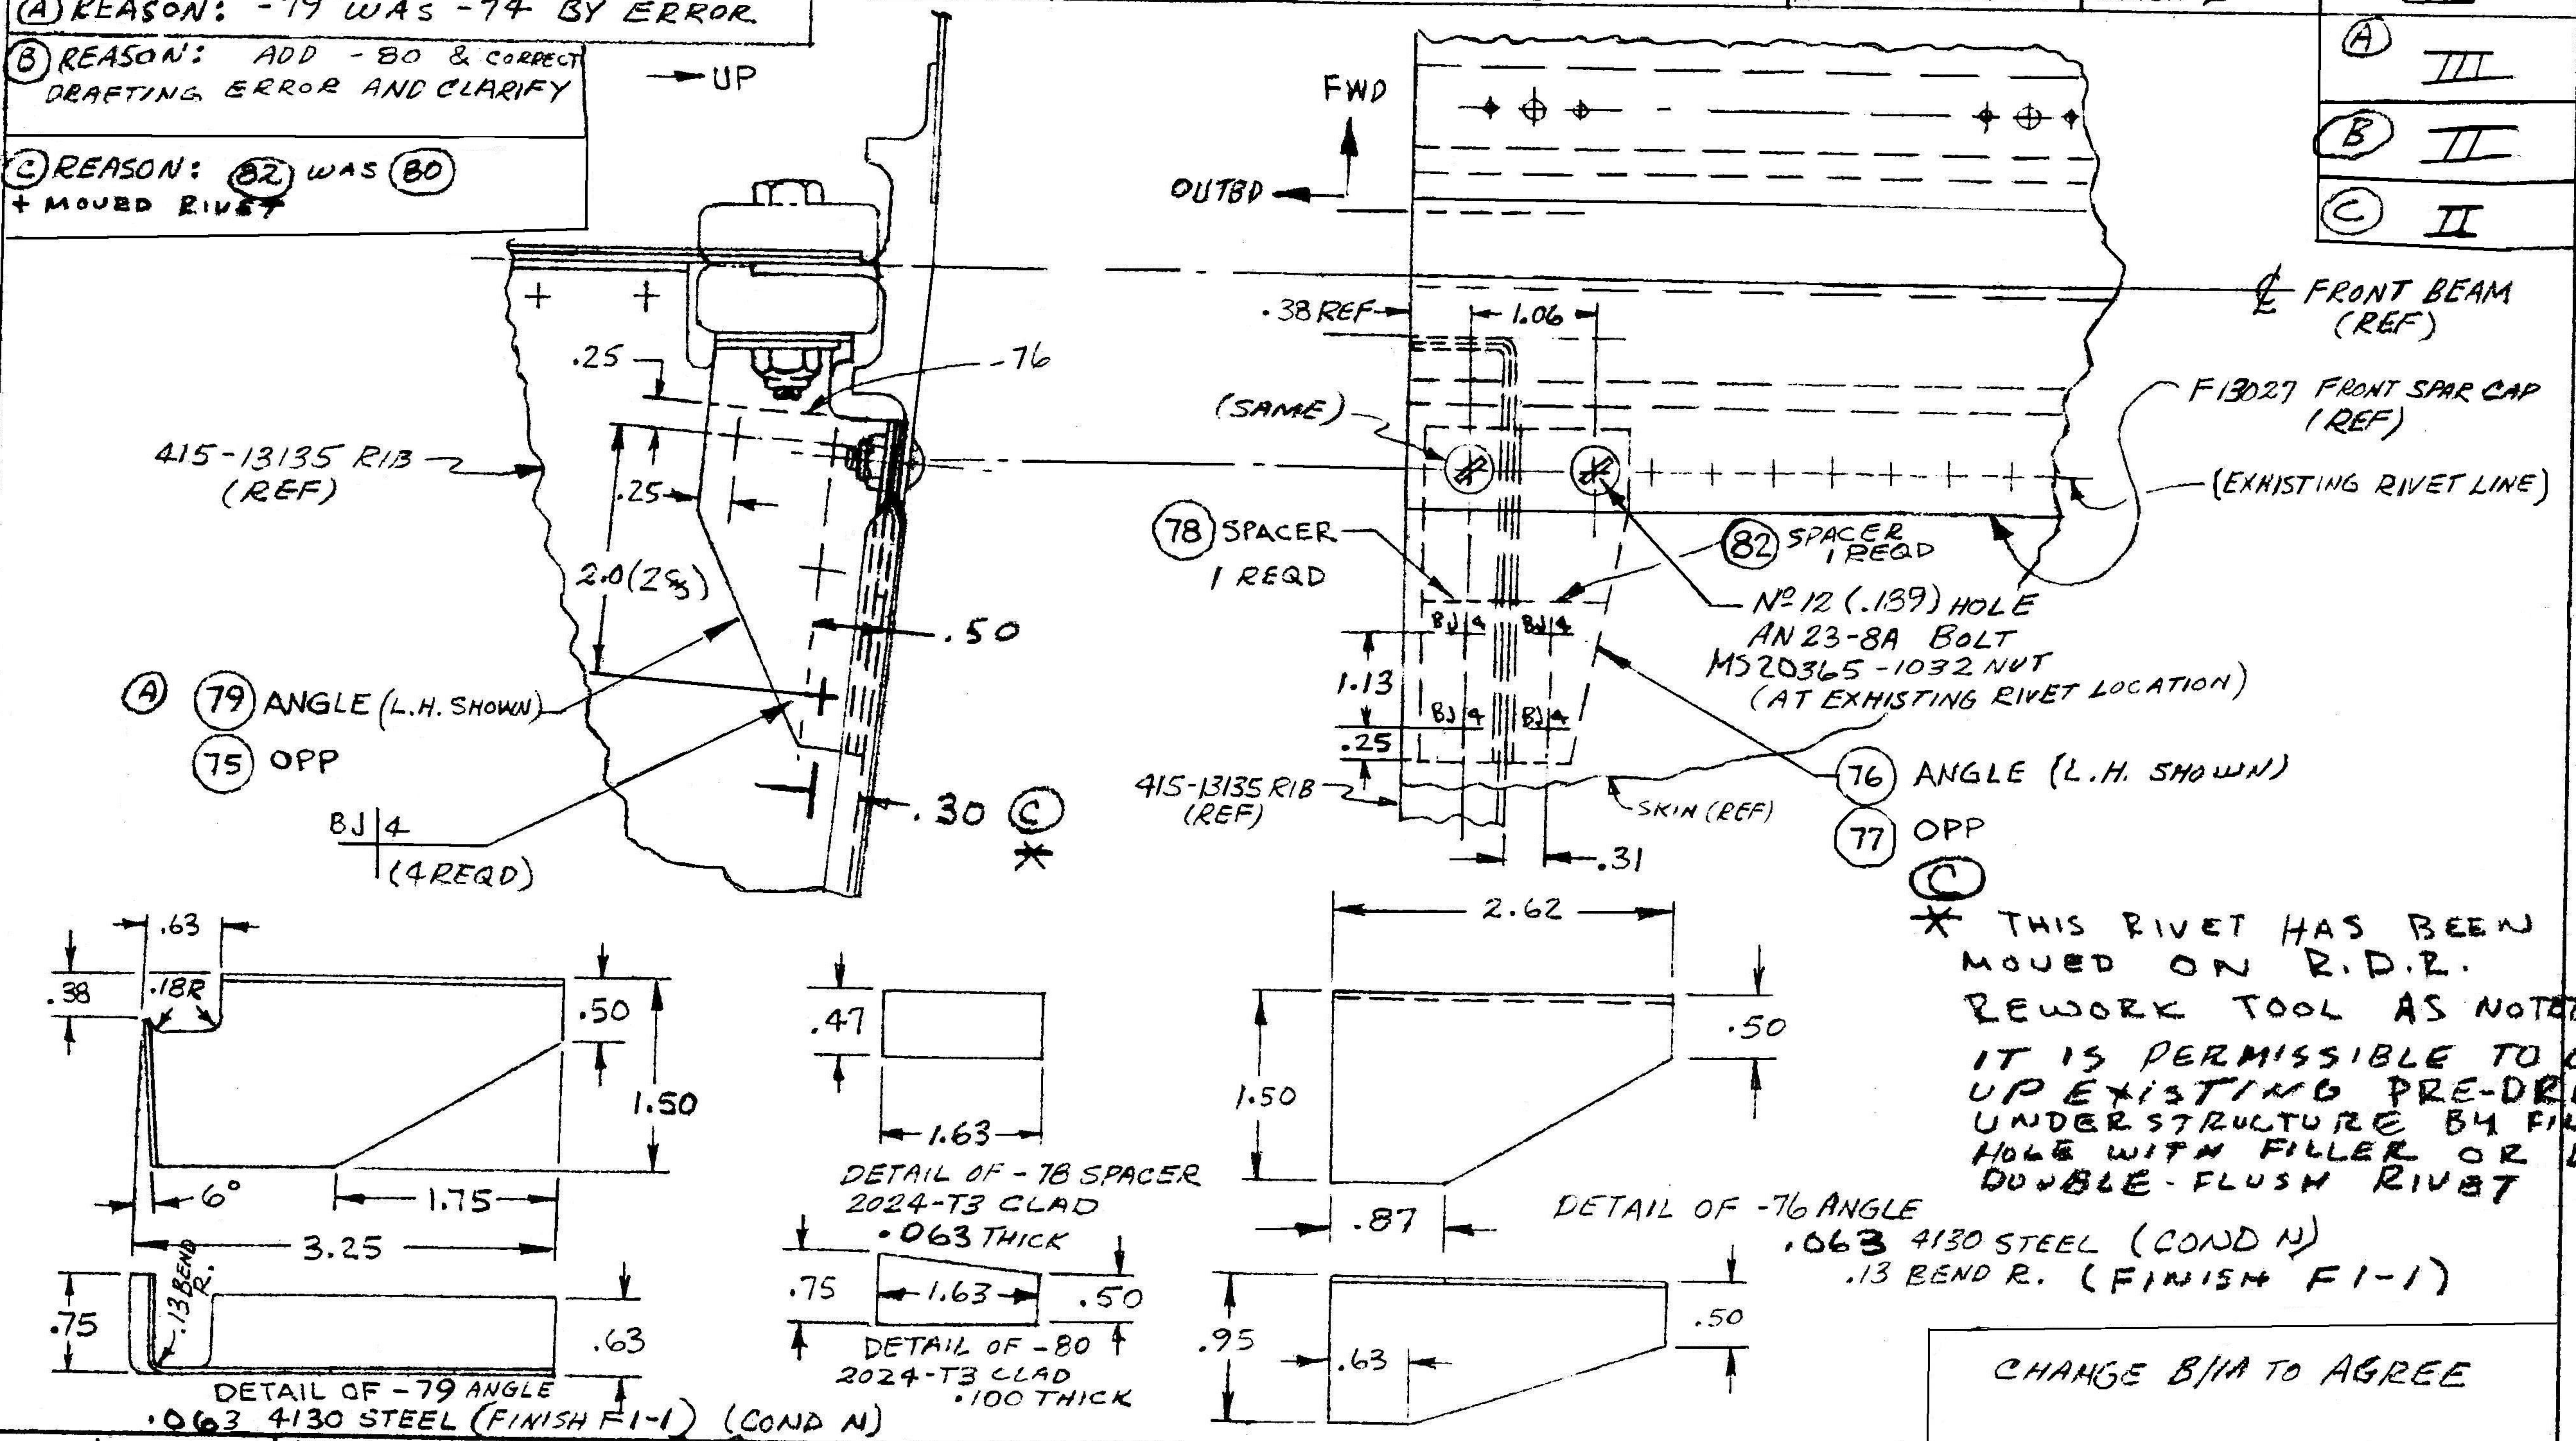
TITLE: ASSEMBLY - CENTER SECTION (FUSELAGE & CENTER SECT. - WING)	ENGINEERING DEPARTMENT ALON INC. McPHERSON, KANSAS	DRAWING NUMBER F 13101	MODEL A2	E.O. NUMBER 5212C
REASON: TO PREVENT FATIGUE CRACKING OF END RIB OF WING CENTER SECTION IN SERVICE	V	CHANGE EFFECTIVE ON A 30 & ON		REQUESTED BY: F.A.A.
THIS NOTICE TO BE USED AS PART OF DWG AND SUPERSEDES AS SHOWN		REV. A CLASS II	REV. B A-30 & ON REVC A 30 & ON	F. A. A. MAJOR <input type="checkbox"/> MINOR <input checked="" type="checkbox"/>
