2011-2016 Ford 6.8L V10 Throttle Control Diagnostics Except "G" Kit

### Underhood70 V900111

### Underhood150 V910011

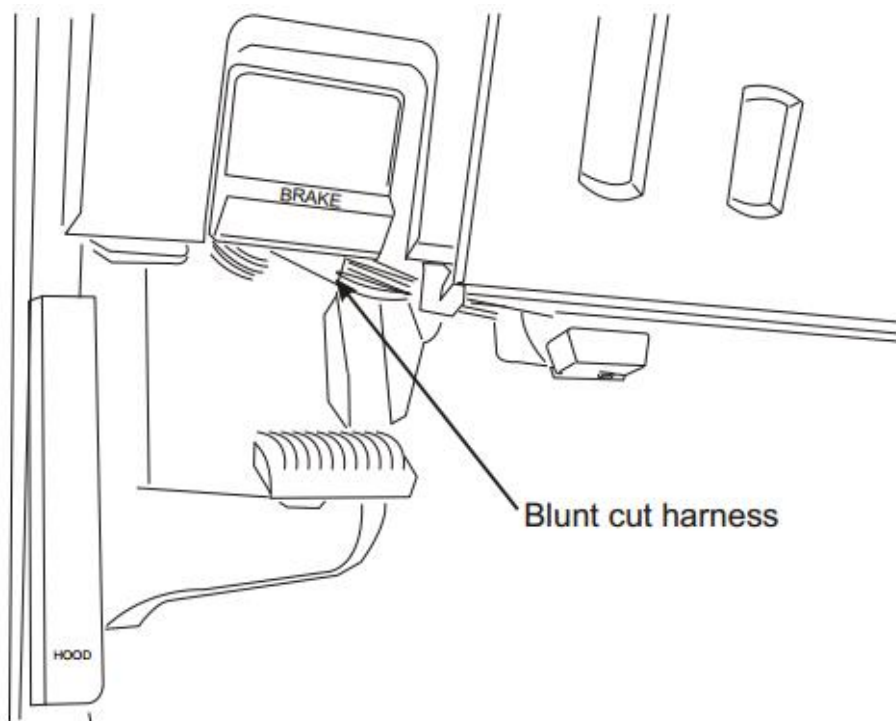
Figure 1 shows the location of the SEIC Blunt Cut Wire Harness where the majority of the Throttle Control connections are made.

Most Throttle Control issues are due to poor electrical connections and/or poor grounding. VMAC recommends that all electrical connections (with the exception of the clutch connector in the engine bay) be soldered and shrink wrapped. We do not recommend using bullet connectors.
