**Subject**  
Underhood Over / Under Pressurizing Except "G" and "Lite" Systems

- System or Parts affected**
- Underhood70 (V900xxx)
  - Underhood150 (V910xxx)

Document	Version	Department	Revision Details	Revised by	Tech	Engineering	Implemented
EXT-VR-004	C	Tech	Article re-work	BDJ 27Aug 2018	DB28Aug2018	N/A	29Aug2018

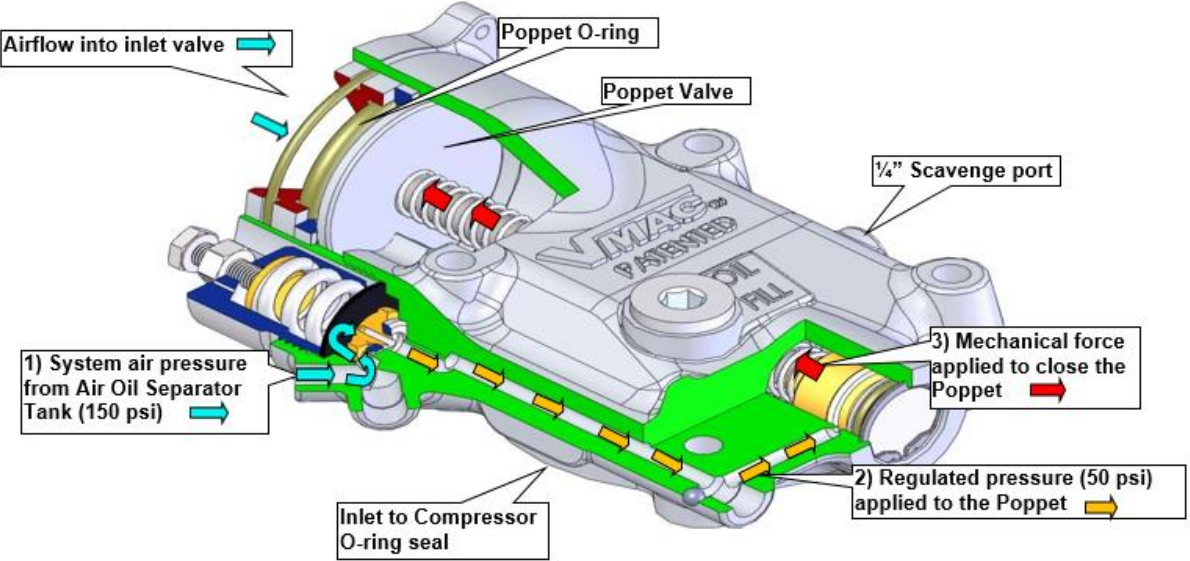
Figure 1

The amount of air pressure VMAC's underhood air compressor creates is controlled mechanically by the inlet valve. If the inlet valve is open the compressor will build pressure. If the inlet valve is closed it should not build pressure. (Figure 1)

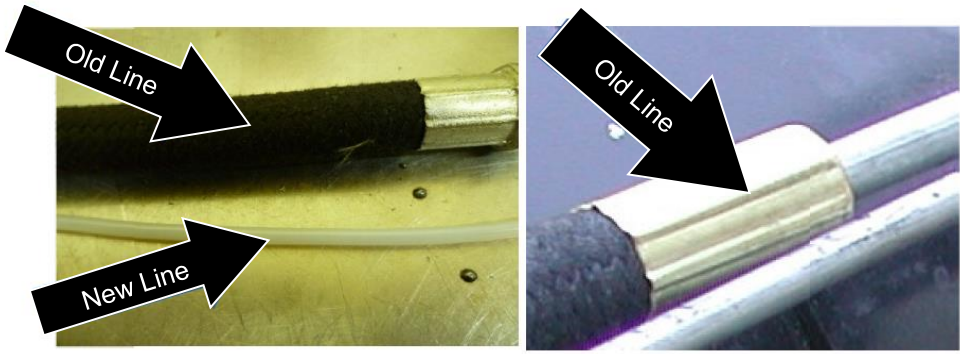
Figure 2

- Age and moisture can cause the old-style steel lines to internally corrode. This corrosion can break free and abrade the liner of the braided hose allowing an internal blister to form, under system pressure, that can block or restrict flow in the pressure control line. If the pressure control line is the old-style steel and rubber line (Figure 2), it is strongly recommended to upgrade it with a PTFE conversion kit (P/N# A700153).

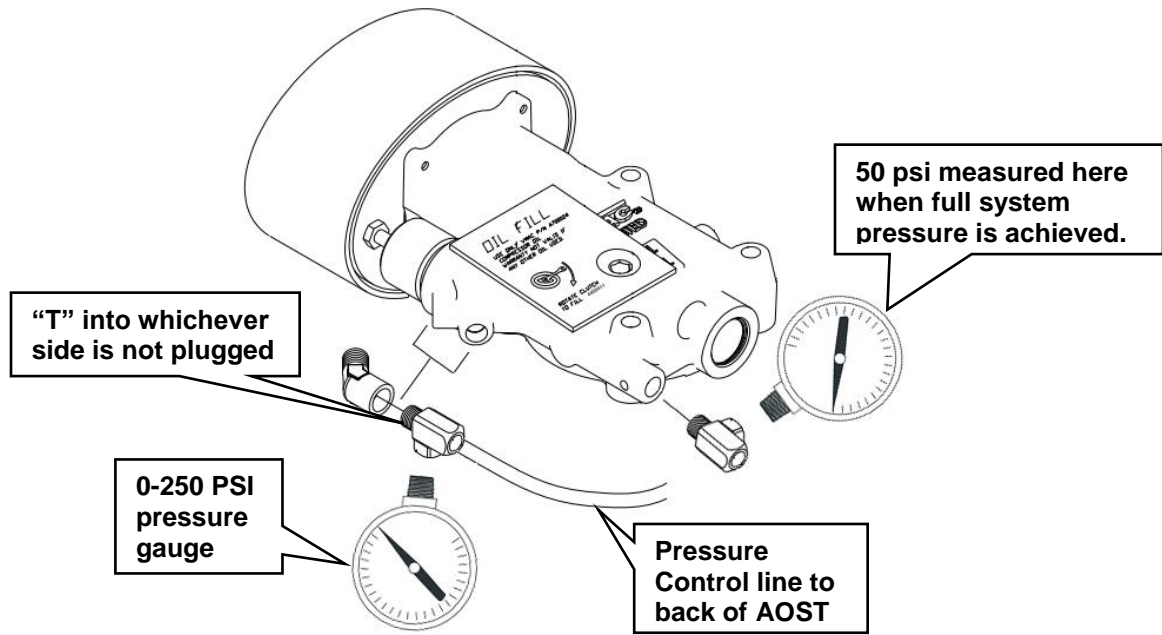
**Figure 3**

- Confirm that there is full system pressure (Approximately 150 PSI set from the factory) reaching the inlet from the AOST via the Pressure Control Line by inserting a "T" fitting and 200 PSI pressure gauge. (Figure 3)
- When full system pressure is achieved, the regulator should supply 50 PSI to the back of the poppet piston to close the poppet. Test by removing the 1/8" NPT plug at back of inlet and installing a pressure gauge (Figure 3). If 50 PSI is present but poppet is not closing, check for sticking poppet.

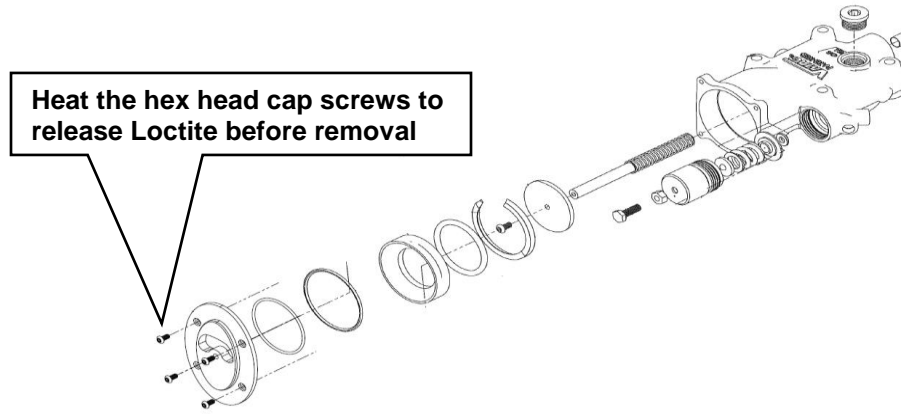
**Figure 4**

- Check for leaks at all fittings, in the pressure control line, scavenge Line, and at the AOST.
- Confirm that the screw in the front of the Poppet is tight (old style inlets) and the O-ring is in good condition (not cracked etc.) and properly seated (Figure 5).
  - Many VMAC compressor configurations will require you to remove the inlet from the compressor to perform this inspection.
  - Heat the hex head cap screws holding the filter plate on to prevent stripping them. (Figure 4)

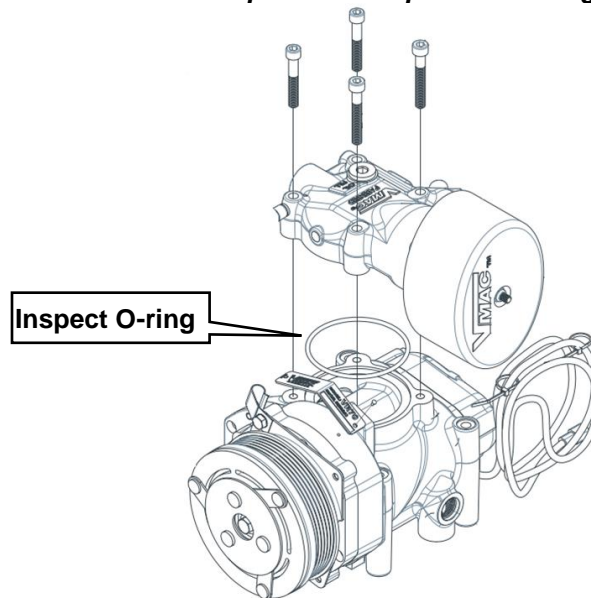
**Figure 6**

- If the poppet O-ring in an old-style poppet valve requires replacement, replace the poppet valve with VMAC part number A700259 RETROFIT KIT, VR INLET POPPET.
- If a new style poppet valve has malfunctioned:
  - Replace damaged O-rings. See Illustrated Parts List for your system  
<https://www.vmacair.com/support/ipl/>
  - If the O-ring in the poppet valve head cannot be moved freely in its groove, replace the poppet valve with VMAC part number A700259 RETROFIT KIT, VR INLET POPPET.
- If it has not already been done, remove the inlet from the compressor. Inspect the O-ring between the inlet and compressor for signs of damage and confirm it is installed correctly. (Figure 6).

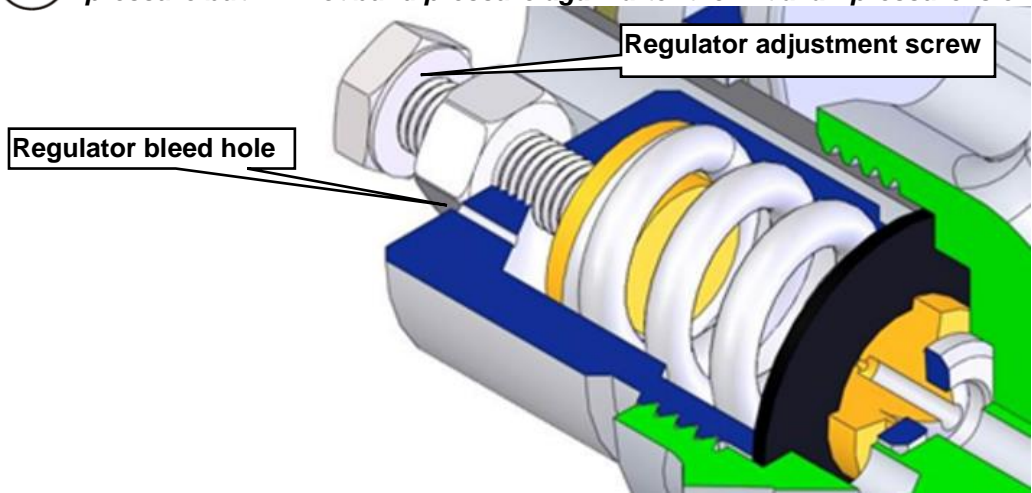
Figure 7

- If proper function of Safety Relief Valve is confirmed, loosen the regulator screw locknut and turn the regulator adjusting screw (Figure 7) counter clockwise two turns. Observe the test tool pressure gauge and watch to see if this results in reduced pressure. If so, adjust the regulator accordingly. (See Owner's Manual <https://www.vmacair.com/wp-content/uploads/Manuals/Underhood/Underhood-Owners-Manual.pdf> )

- Connect VMAC Test Tool (P/N# A700052) directly to Air Oil Separator Tank (AOST).
- Ensure there is no blockage or restriction to prevent air flow into the inlet – dirty air filter, foreign object etc.
- With engine running and system turned on, loosen the regulator adjusting screw locknut and slowly turn the adjusting screw clockwise while observing the test tool pressure gauge. If pressure increases, adjust regulator accordingly (See your Owner's Manual).
- Check the bleed hole on the front of the regulator to make sure it's not plugged

**NOTE** *If the regulator bleed hole is plugged, the compressor will initially build to full system pressure but will not build pressure again after the initial air pressure is exhausted.*

- Remove the air filter cover and air filter. Using a screw driver push the poppet to open the inlet valve with the vehicle and compressor running. If the system builds air, the regulator is faulty. Replace the regulator kit using P/N#A700137
  - To view installation instructions for A700137 Regulator assembly see: <https://kb.vmacair.com/help/a700137-regulator-assembly-instructions>
