Subject
Blowdown Cap Operation and Troubleshooting

UNDERHOOD® VR70 & DTM	UNDERHOOD VR150	Hydraulic Driven (Predatair)
Blowdown Cap P/N# 9200437	Blowdown Cap P/N# 9210028	Blowdown Cap P/N# 9400059

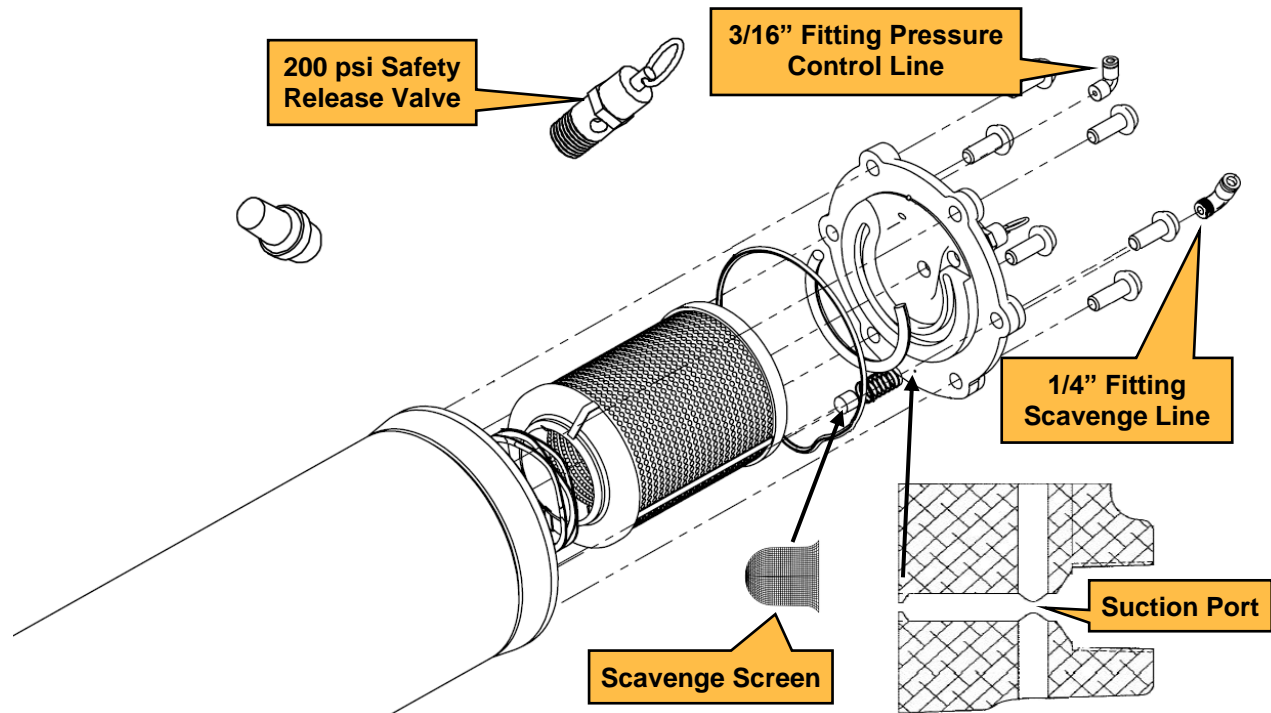
Figure 4 - Components

Blowdown constantly venting during compressor operation

- Determine if venting air is from the Blowdown Muffler or the 200PSI Pressure Relief Valve.
- Check the 1/4" scavenge line for leaks, kinks or obstructions.
- Check 1/4" scavenge fittings for leaks, or obstructions.
- Inspect the scavenge port in the blowdown cap. Ensure it is not obstructed.
- Ensure the scavenge screen is not plugged.

Blowdown does not vent

- Plugged muffler: This will prevent the air pressure from venting.
- Ball seized onto seat: Remove cap from tank, and shake the cap. The ball move should move freely inside, like in a paint can.

Oil comes out of Blowdown Muffler

- Blowdown diaphragm* is damaged.
- Tank or cap mounted is upside down (Arrow on discharge cap should be pointing upwards).

System takes a long time to Blowdown

- Restricted Blowdown muffler.
- External receiver tank installed without a one-way check valve between the AOST and the tank.
