Subject
Blowdown Cap Operation and Troubleshooting

UNDERHOOD® VR70 & DTM	UNDERHOOD VR150	Hydraulic Driven (Predatair)
Blowdown Cap P/N# 9200437	Blowdown Cap P/N# 9210028	Blowdown Cap P/N# 9400059

Document	Version	Department	Revision Details	Revised by	Tech	Engineering	Implemented
EXT-ALL-006	C	Tech	Syst update, format	BDJ 2 Apr.2024	N/A	N/A	11 Sept.2018

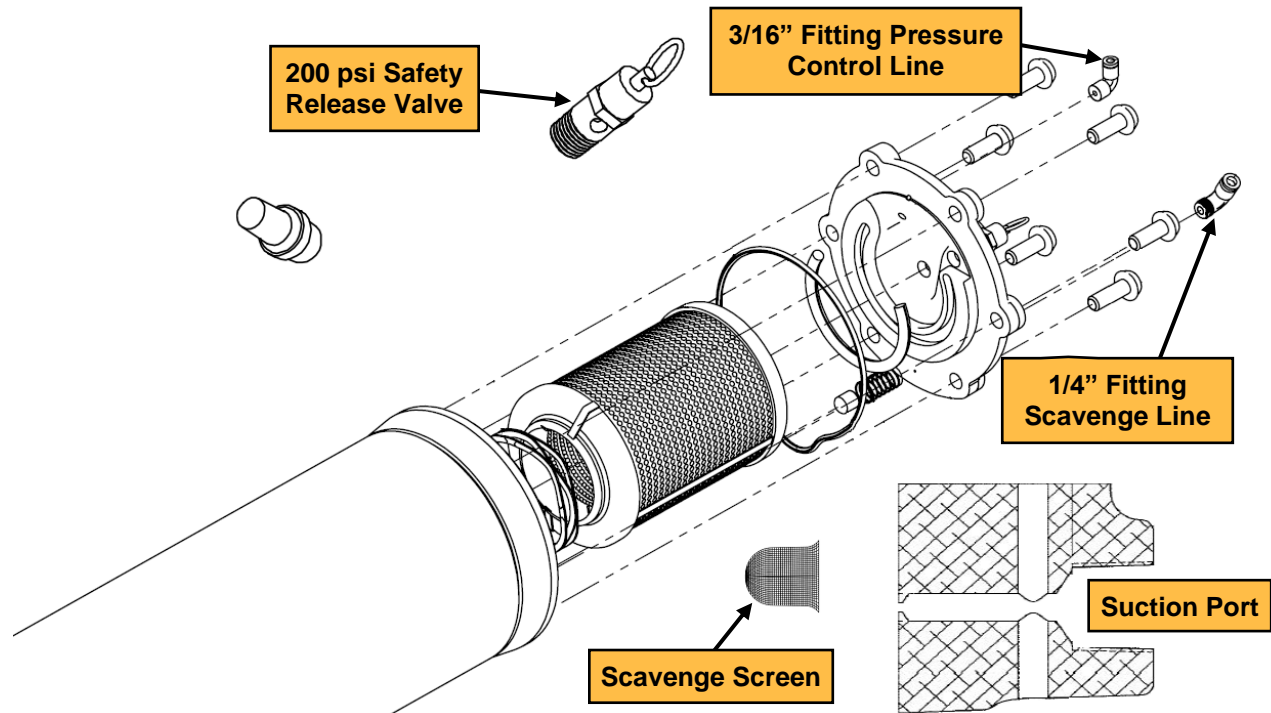
Figure 4 - Components

Blowdown constantly venting during compressor operation

- Determine if venting air is from the Blowdown Muffler or the 200PSI Pressure Relief Valve.
- Check the 1/4" scavenge line for leaks, kinks or obstructions.
- Check 1/4" scavenge fittings for leaks, or obstructions.
- Inspect the scavenge port in the blowdown cap. Ensure it is not obstructed.
- Ensure the scavenge screen is not plugged.

Blowdown does not vent

- Plugged muffler: This will prevent the air pressure from venting.
- Ball seized onto seat: Remove cap from tank, and shake the cap. The ball move should move freely inside, like in a paint can.

Oil comes out of Blowdown Muffler

- Blowdown diaphragm* is damaged.
- Tank or cap mounted is upside down (Arrow on discharge cap should be pointing upwards).

System takes a long time to Blowdown

- Restricted Blowdown muffler.
- External receiver tank installed without a one-way check valve between the AOST and the tank.
