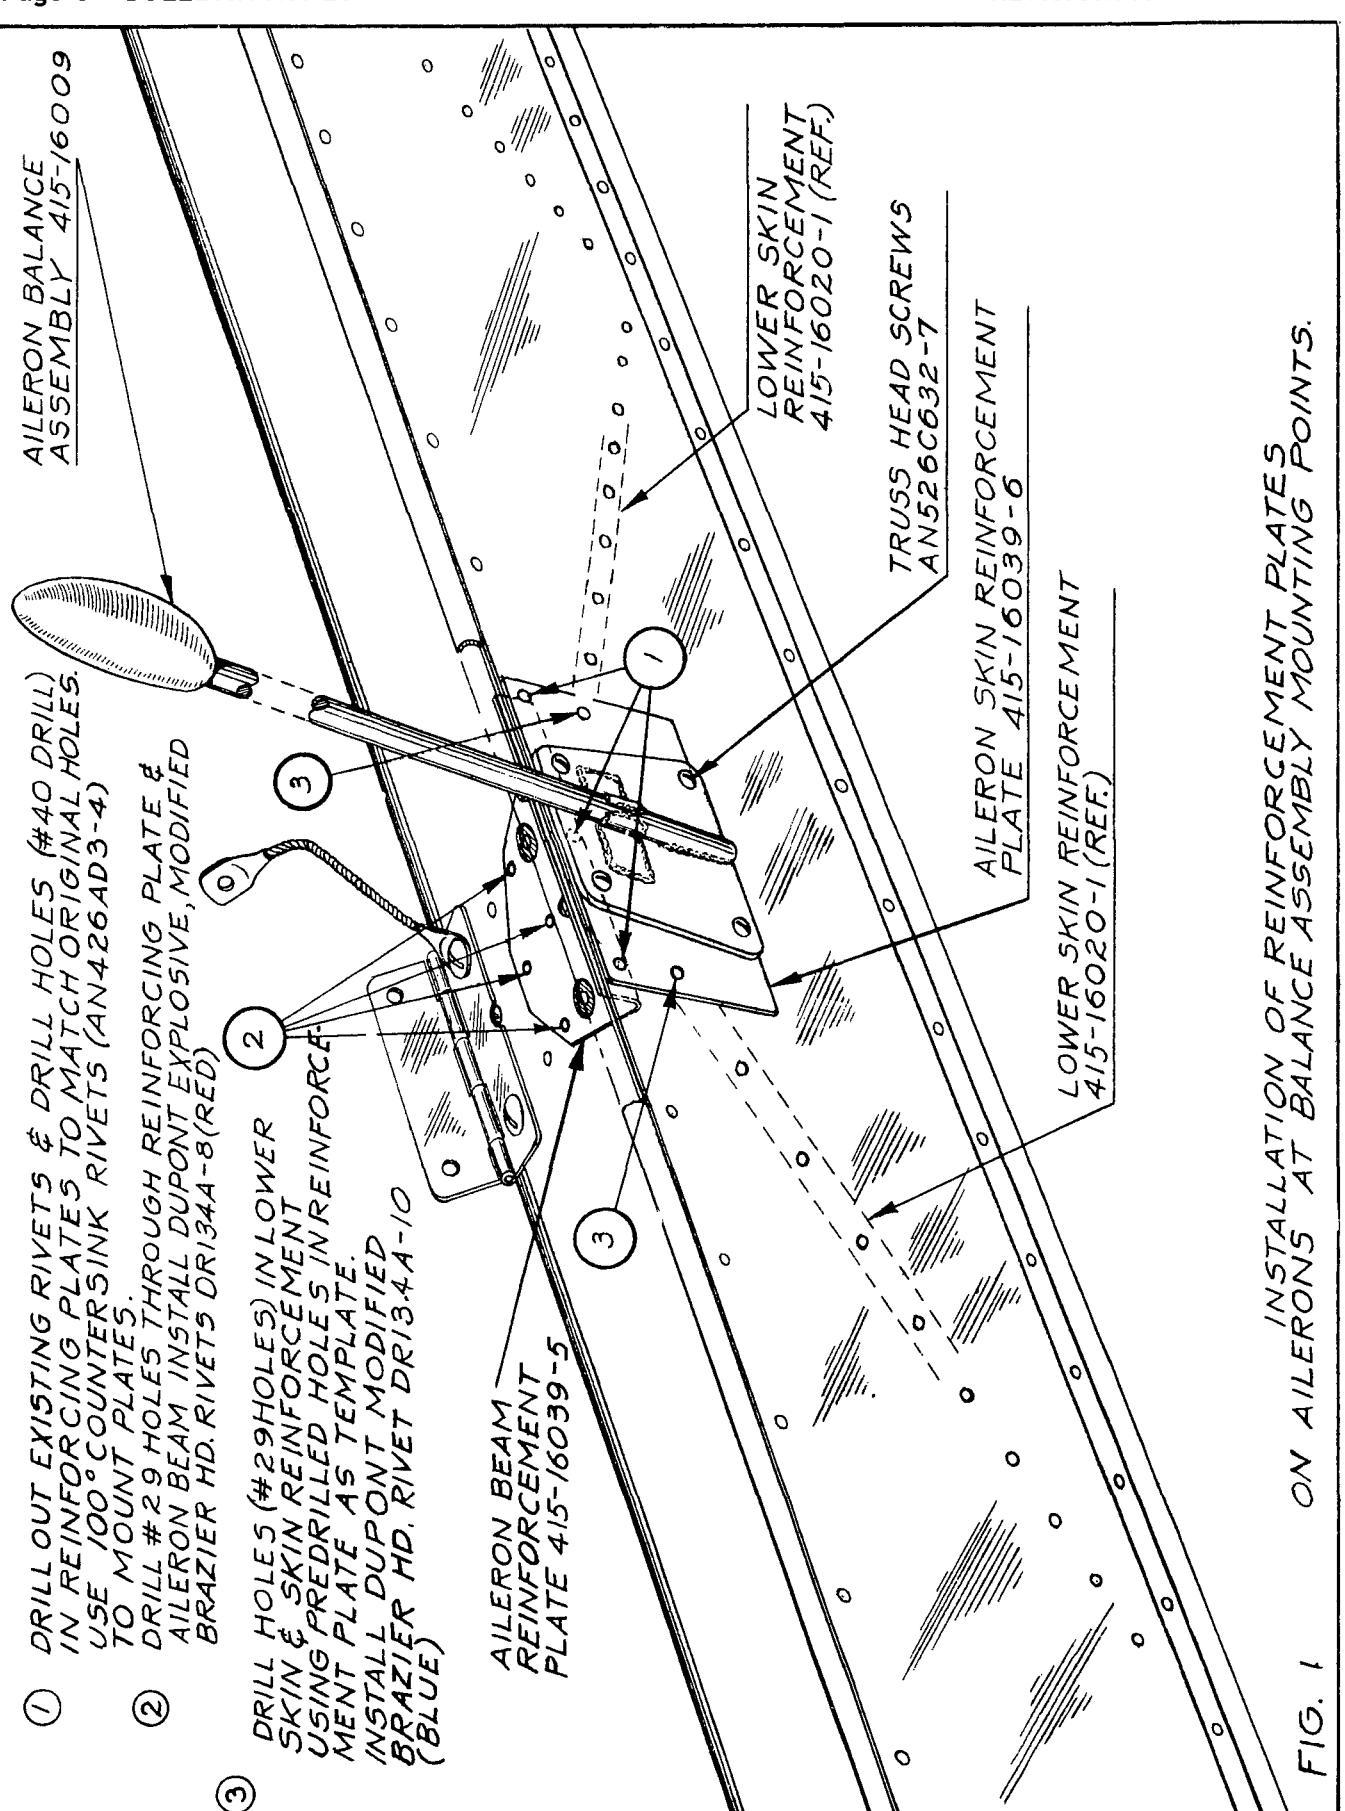
It has been found desirable to increase the strength of the aileron balance weight bracket to beam attachment. As is our policy, the information necessary to incorporate the improvement in delivered Ercoupes is presented. The modification required to obtain the added service life is the addition of two reinforcement plates to each aileron. It is recommended that this bulletin be complied with not later than the next 100 hour inspection except where visual inspection shows the immediate need of a repair.

- (3) Drill out the three 100° countersunk rivets from the aileron beam and lower skin seam at the balance assembly attaching flange. See 1 on Figure 1, page 4.

- (5) Insert Cleco buttons or other type fasteners in these three holes. Drill four No. 29 (.136) holes through aileron beam using the beam reinforcement plate as a template. See 2 on Fig. 1, page 3.

- (9) Drill two No. 29 (.136) holes through skin using holes in reinforcement plate as template. See 3 on Fig. 1, page 3.

- (10) Remove skin reinforcement plate and burr all holes.
- (11) Replace both reinforcement plates, using Cleco buttons or other type of fasteners to hold plates in place.
- (12) Rivet beam reinforcement plate to beam, using four Dupont Explosive Modified Brazier Head Rivets (DR134A-8) (Red) (Marked as 2 in Fig. 1, page 3). Dupont rivets should be set with a Dupont Riveting Iron; however, a heavy duty electric or torch heated soldering iron may be used as a substitute.
- (13) Rivet the skin reinforcement plate to the lower skin using two Dupont Explosive Modified Brazier Head Rivets (DR134A-10) (Blue) (Marked as 3 in Fig. 1, page 3.)
- (14) Countersink the three holes in the lower side of the skin reinforcement plates 100°

and rivet both reinforcement plates along lower aileron beam flange using three 100° countersunk rivets (AN426-AD3-4).
