ERCOUPE SERVICE BULLETIN NO. 35

AILERON PUSHROD AND INBOARD AILERON INSPECTION

DATE: August 25, 2014, Revision A

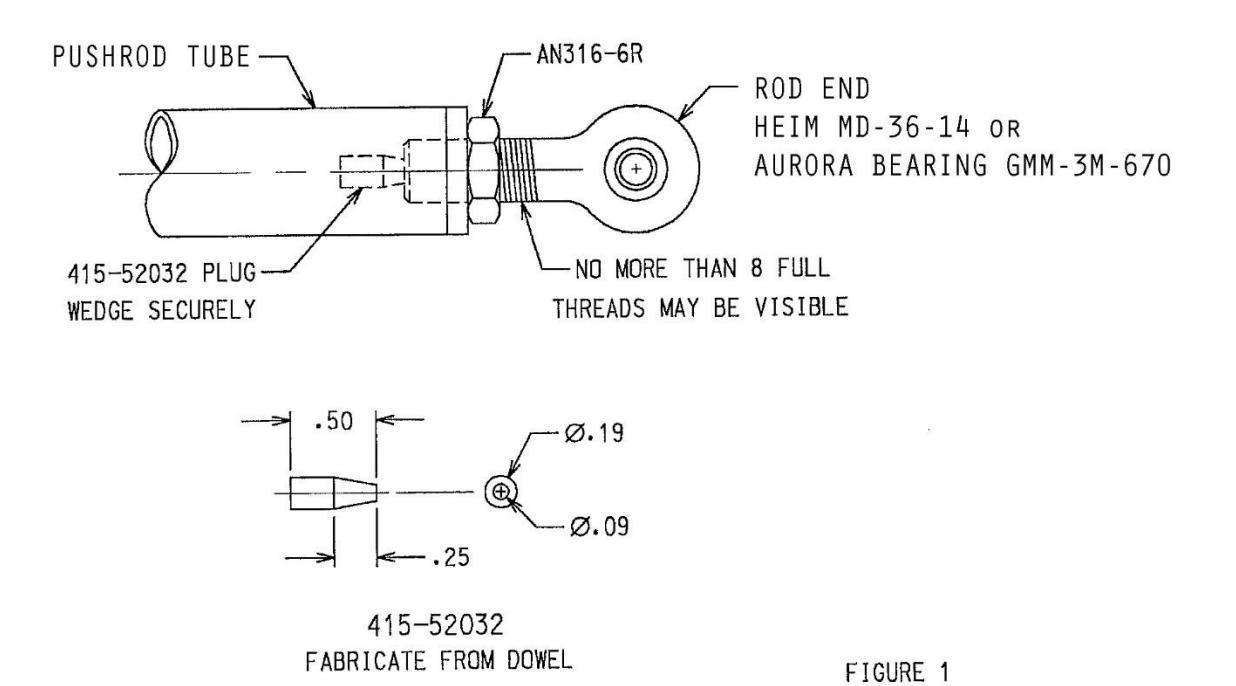
There have been several field reports of internal corrosion found on Ercoupe aileron pushrod tubes, p/n F52034, p/n A52436-1, and 914078-001. This is the short pushrod from the bellcrank to the aileron. This internal corrosion was detected at the low side of the aft end of the pushrod where moisture may collect. Typically, the extent of this corrosion has only been found by removing paint from the tube.

- 6. Inspect for any signs of internal corrosion and rust, paying particular attention to the lower side of the aft end of the tube. Tap pushrod on its end on a bench and look for any rust particles exiting open end of tube.
- 7. If any corrosion or rust is found, replace the aileron pushrod tube with a new or used serviceable unit.
- 8. Prime and paint pushrod tube per paint manufacturer's directions. Internally oil tube with Val-Oil, or any alternate preservative conforming to Federal Specification TT-S-176D or MIL-C-16173E Grade IV.
- 9. Service rod-end bearings per Ercoupe Memorandum No. 46, Relubrication of Sealed Bearings. Insure that 415-52032 wooden plug is installed in the end of each rod-end bearing. See Figure 1 at the end of this bulletin.
- 10. Install rod-end bearings in pushrod tube in accordance with existing data. See Figure 1 of this Service Bulletin.
