Alternative J3 Trim Indicator Fix:

David Coats Tyler, Texas, dacoats@cox.net
From Cub Clues #135 July/August 2006

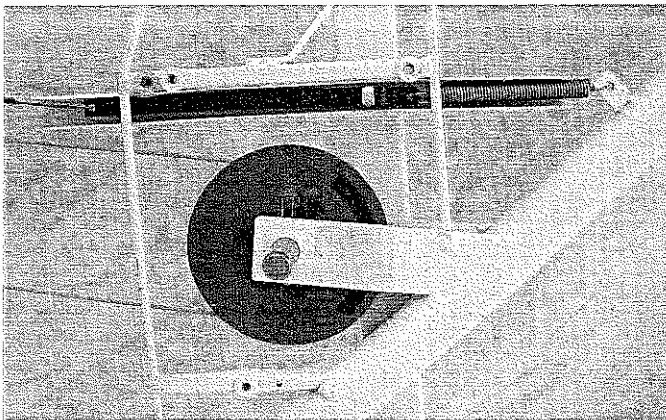
Full nose down trim. Entire section of 'U' channel welded in place. Note the angle the wire makes at the far left of the indicator strip.

The larger U channel used is brazed just underneath the other Ti channel and is about twice the size of the upper U channel which faces outward, The brazed on "guide" U channel faces inward and extends aft about one and one half inches.

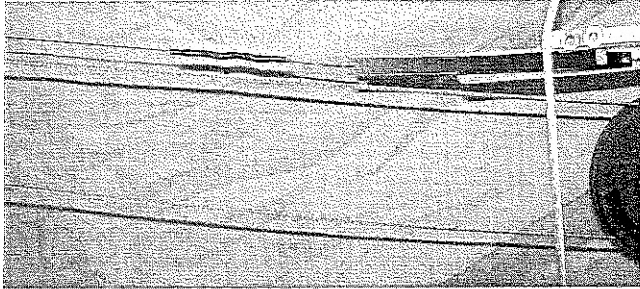
Full nose up trim, the indicator strip is still held in place, not allowing the rivet to twist and gouge the faceplate.

Basically, extend it aft to just where the upper edge would almost engage the trim wire with the nose in the full up position. Two photos show the travel of the trim mechanism. One can also see a loop of safety wire through a drilled hole that helps constrain the sliding mechanism from twisting and therefore allows the "rivet" to move exactly like the rivet moves with Clyde's rerouted wire. In this case, there is no rerouting of the wire. There is still going to be upward force on the metal mechanism, but now it is steel against steel and the small rivet does not wallow out the slot in the aluminum faceplate. Incidentally, I placed a single layer of very thin high grade Teflon tape inside this U channel which should last for quite some time and reduce the frictional load.

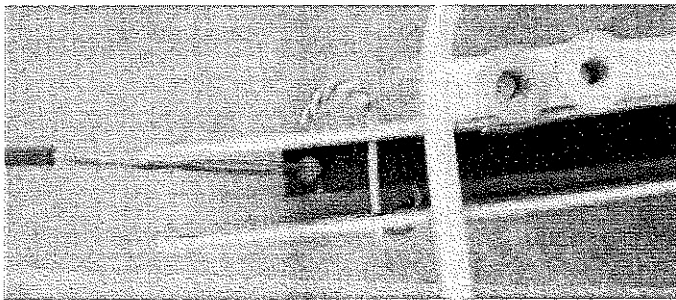
With a safety wire loop in place, the indicator strip is fully captured.

As Clyde describes in his article, this is a job to do when a recover is being done. I also used a small piece of shrink wrap over the twisted end of the piano wire; it didn't work as well as I would have expected - i.e. the trim wire is so slippery that the heat shrink over the wire slipped back on the wire. A smaller diameter piece might have worked better. So, I cut it off and used a piece of flat waxed electronic type nylon lacing tape to be sure there is no slipping of the twisted wire. This appears to work equally well and you don't have to remember to put it on the wire before stringing it and adjusting the tension, etc. My mechanic says this minor modification to the trim indicator is part of the repair and overhaul of the fuselage frame. No 337 is necessary.
