Ridgeland Common

Existing Conditions Study

Final Report

June 2007

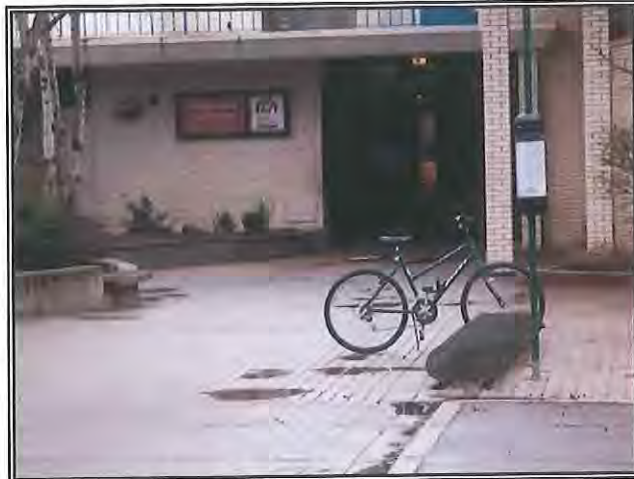
Despite the fact that Ridgeland Common has become physically and functionally obsolete, it continues to provide a home to many popular events and programs for Oak Park residents.

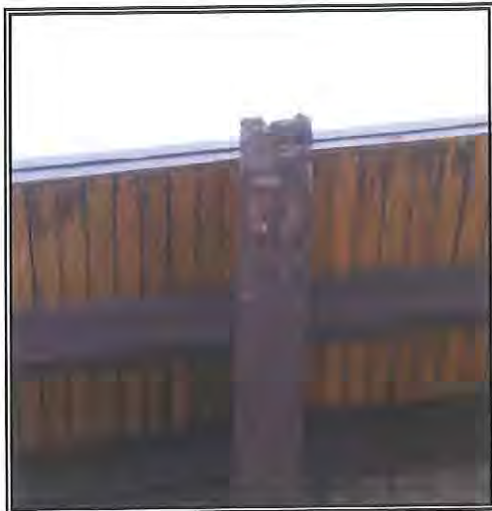
A deteriorated beam end, identified in the architectural assessment, illustrates the need for substantial repairs at Ridgeland Common.

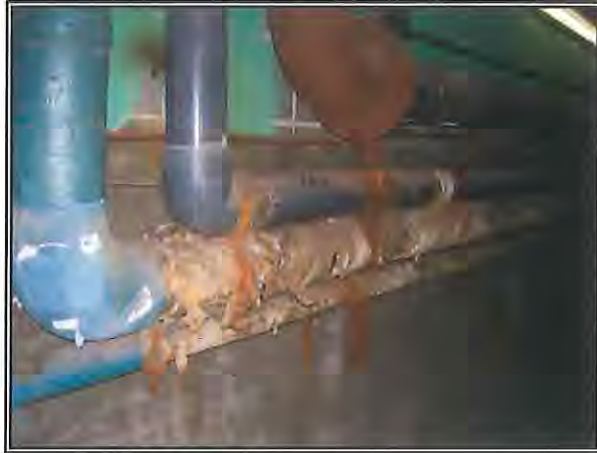
Building systems in disrepair are a common sight at Ridgeland Common and cause many day to day maintenance issues. Unfortunately, undertaking extensive renovation/repair is costly and time consuming.

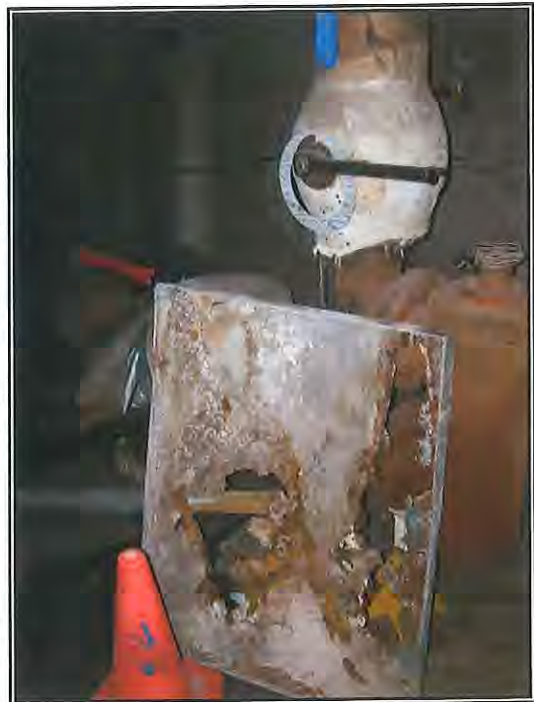
Deferred maintenance costs the Park District thousands of dollars each year and is the source of many system failures. These system failures are beginning to affect the Park District's programming on an increasing basis.

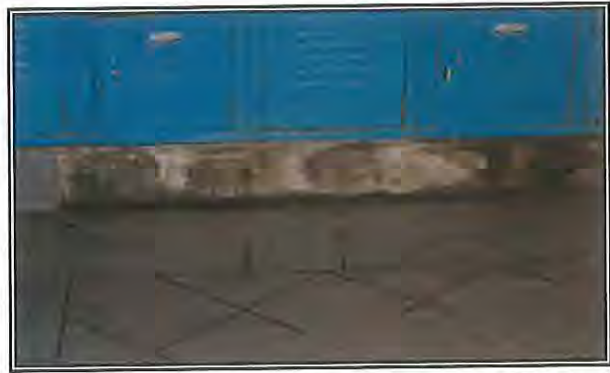
Despite recent renovations, many common areas at Ridgeland Common are in need of repair or replacement.

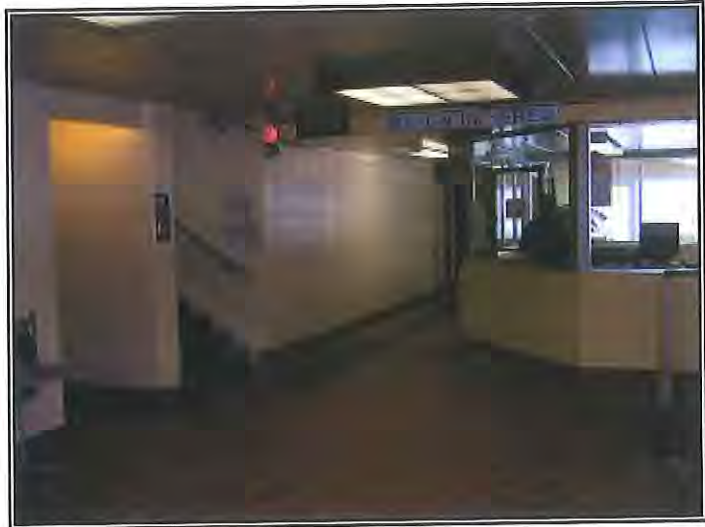
An outdated floor plan results in congestion and circulation issues in the building. Over - programming and program overlap exacerbate these problems, particularly at peak usage times.

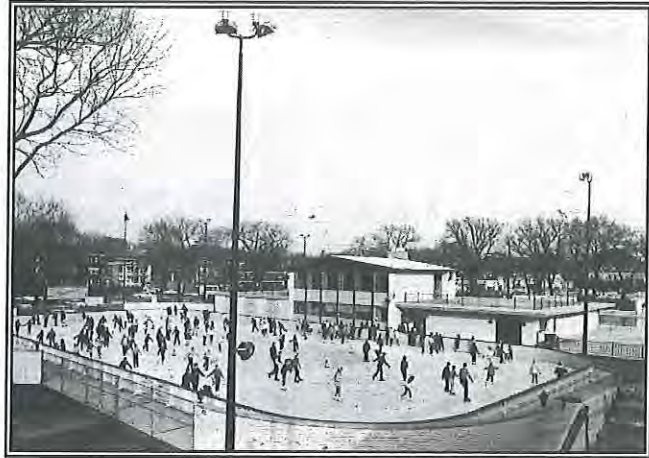
Ridgeland Common was originally constructed with an outdoor ice rink, which was fully enclosed in 1982. Since that time refrigeration equipment encased in the rink structure continues to deteriorate.

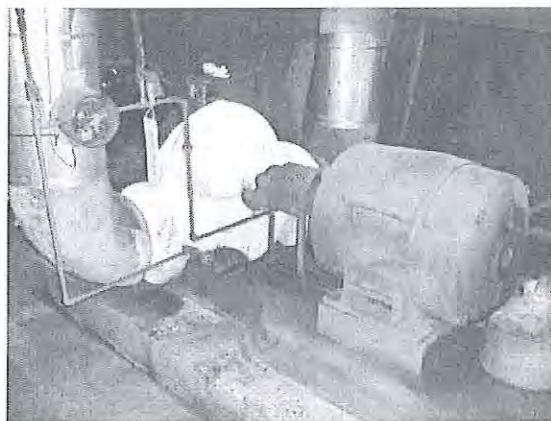
Figure 2-2: Ice Rink Brine Pump

The tubes imbedded in the ice rink concrete slab are twenty-two years old and the make-up water added this year was already more than twice the amount of last year's make-up water. This could only mean that there is leakage in the tubes imbedded in the ice rink concrete slab. *The leaking tubes imbedded in the ice rink concrete slab should be replaced.*

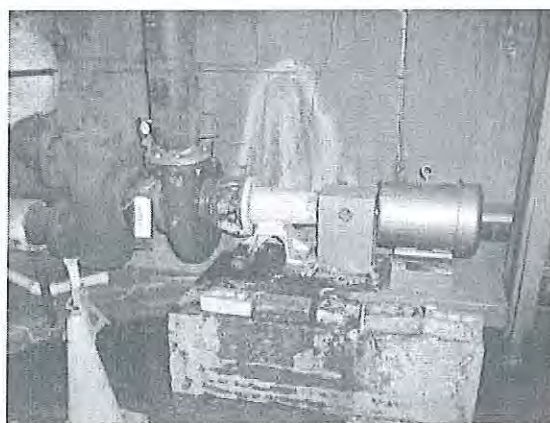
Figure 2-3: Condenser Water Pump

The chillers and the dehumidifiers use the swimming pool, located outside the building, as a heat sink when ice rink is operating. During this time, the pool is closed for the season. The pool water is chemically treated to meet the Department of Public Health's requirements and is operated with a 7.4 pH. Figure 2-3 shows the condenser water pump. The pump is old but is in fair working condition. An evaporative type condenser, located on the roof, is connected to the refrigeration system but had never worked. A pump circulates the pool water through the condensers of the chillers and the dehumidifiers.

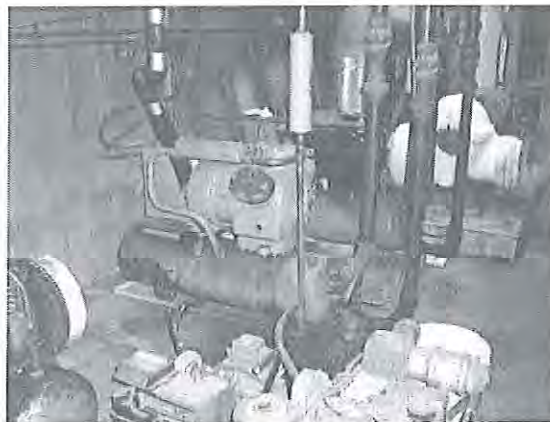
Figure 2-4: Dehumidification System Condensing Units

Two wall-mounted humidistats, located in the ice rink, maintain humidity in the ice rink by operating the air-handling units and compressors. The dehumidification system is about two years old. At present, the dehumidification system is not working due to defective parts. *The dehumidification system should be repaired to maintain humidity in the ice rink.*

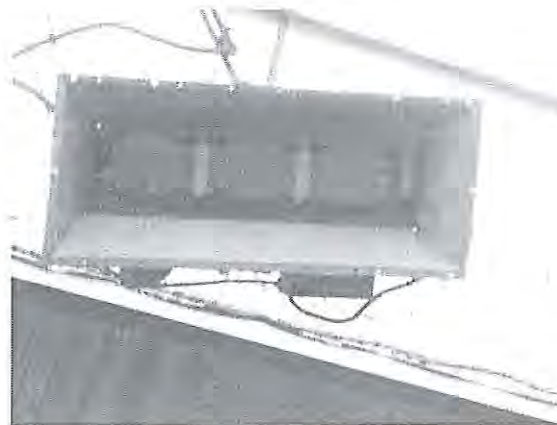
Figure 2-5: A Typical Gas-Fired Infrared Unit

There are eleven gas-fired infrared heating units in the ice rink. These units are of high-intensity type un-vented infrared units that are located above the seating areas and used to heat the seating areas the only. Figure 2-5 shows a typical infrared unit. The maintain staff manually turns on and off these units as required to maintain comfort. At present, two of these units are new but three other units remain non-operational. *All old gas-fired infrared heating units should be replaced with new vented and continuous type gas-fired infrared heaters and be provided with electronic controls.*

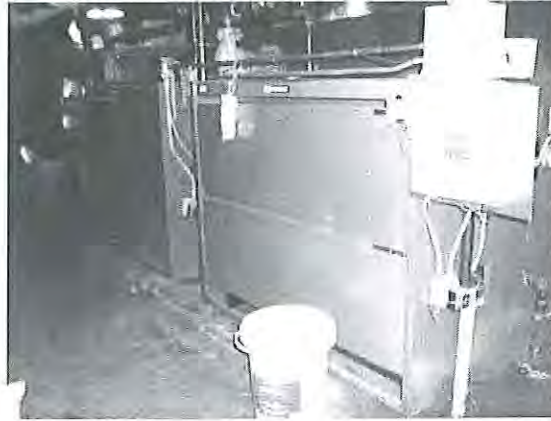
Figure 2-6: Hot Water Boilers

A Heat-Timer controller controls the operation of the boilers during winter and reset the hot water generated based on outdoor air temperature. The boilers are about six years old and are in good operating condition.

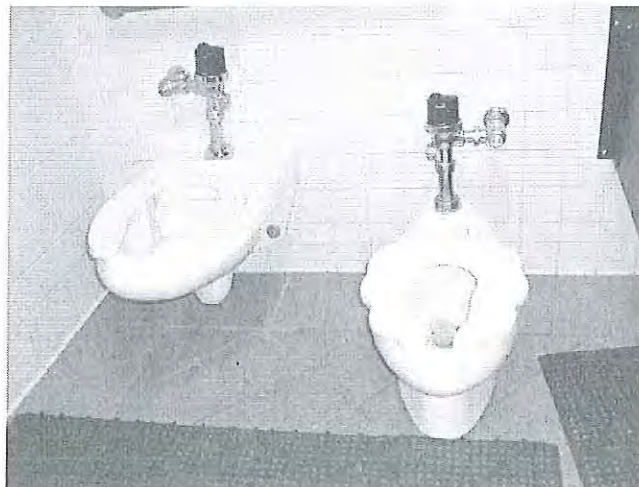
Figure 2-11: Typical Water Closets

Hot and cold water for domestic use is distributed to plumbing fixtures in the washrooms, locker rooms, and shower rooms. Typical water closets are shown in Figure 2-11. Some of the water closets are equipped with battery-operated automatic flush valves, but the majority of these fixtures are equipped with manually-operated flush valves originally installed with the building. *We recommend that the plumbing fixtures are replaced with ultra low flow fixtures for water conservation.*

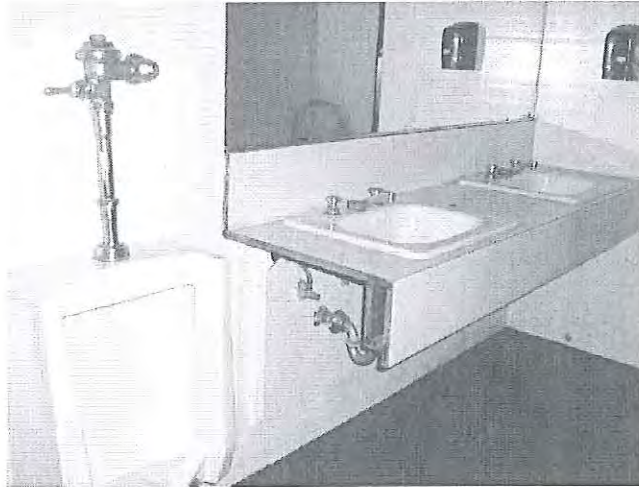
Figure 2-12: Typical Urinal

A typical urinal is shown in Figure 2-12. All urinals are wall-mounted and equipped manually-operated flush valves. The countertop lavatories shown in the figure are equipped with two-handle faucets, but most of the typical lavatories are equipped with one-handle faucets as shown in Figure 2-13.

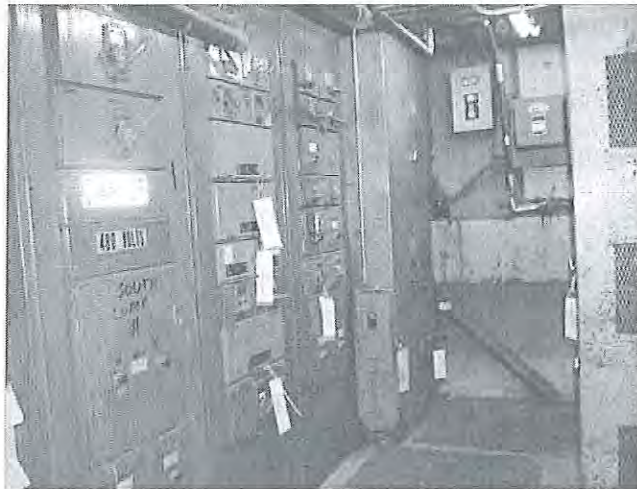
Figure 2-15: Square D Distribution Panelboards

In addition, the transformer is directly in front of LP-B and LP-A restricting minimal access to the panels. Both lighting panels should be replaced with new panels including all associated wiring to existing loads. The new panels should be relocated such that the transformer does not block them in order to provide code required working space.

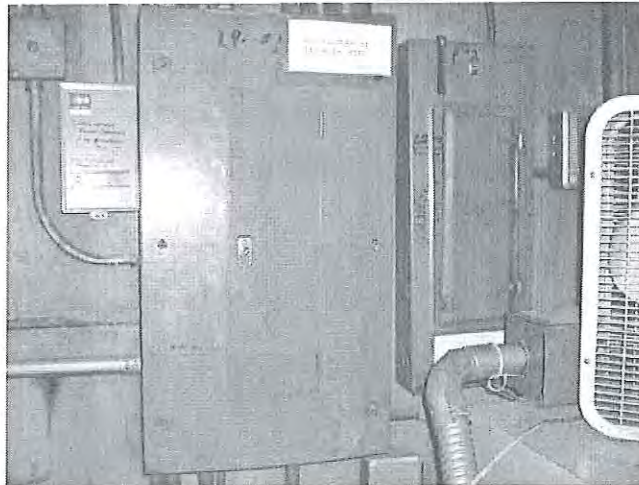
Figure 2-17: Lighting Panel LP-A and LP-B

The Square D power distribution panelboard has three separate sections; an 800A, 600A and a 400A (see Figure 2-15). These 277/480V, 3-phase panelboards serve various mechanical equipment motors, pumps, and disconnect switches as well as two lighting panels, LP-A and LP-B via a 75kVA transformer (see Figure 2-16 and Figure 2-17). *The Square D power distribution panelboard is in fair condition; it should be replaced with new distribution panelboards. The 75kVA transformer is in good condition, The transformer is currently sitting on bricks that have been placed underneath it. It should be mounted on an equipment pad.*

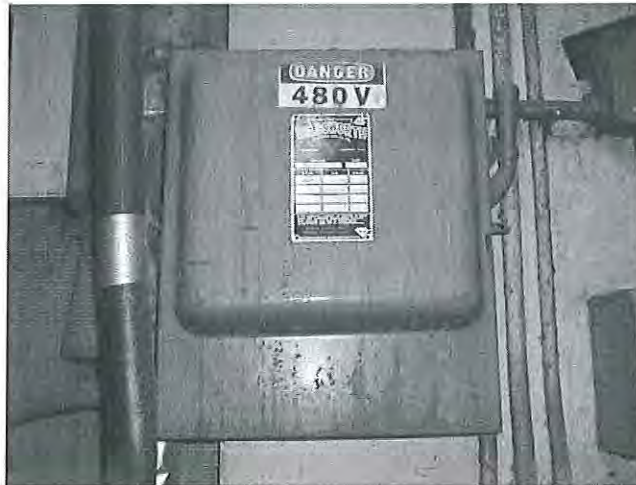
Figure 2-18: 480V Emergency Switch

There is also a feed to a 480V, 30A, emergency switch (see Figure 2-18). A small 3kVA transformer (see Figure 2-19) is connected to the emergency switch stepping down the voltage to 120/240V for a 30A emergency exit/public fuse box. The fuse box has two 20A fuses for emergency lighting (see Figure 2-20). *All of these electrical items are in very poor condition. The exit/public fuse box should be replaced with a new emergency panelboard with a corresponding new transformer through a new automatic transfer switch for emergency power requirements. All new conduit and wire should be provided when new equipment is installed.*

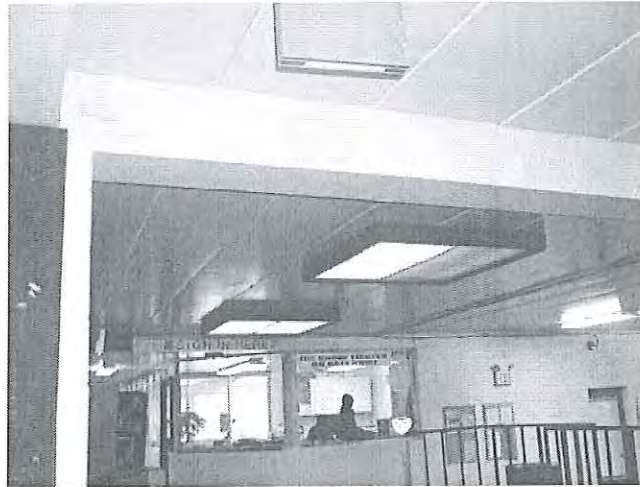
Figure 2-25: Main Lobby Area Lighting

Most of the lighting at Ridgeland Common is T-12 fluorescent technology with two, three, or four lamp fixtures and magnetic ballasts (see Figure 2-25). There are areas within the facility that have been retrofitted with T-8 fluorescent technology with electronic ballasts. When old lamps are in need of replacement, as an ongoing process, the facility maintenance staff is retrofitting these fixtures with T-8 lamps and electronic ballasts.

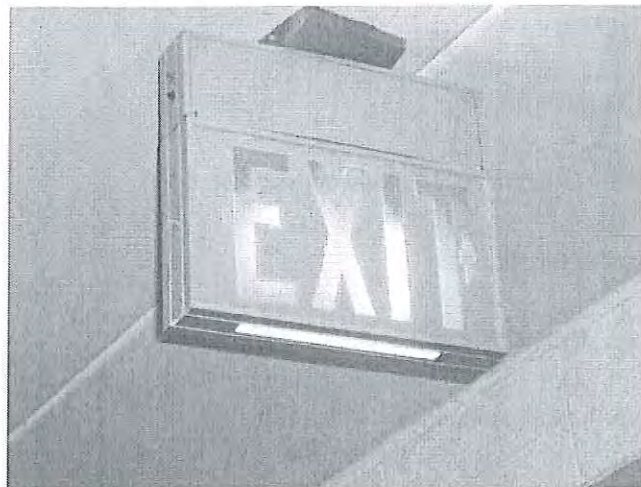
Figure 2-26: Typical Exit Sign

Most of the existing exit signs are old and have incandescent lamps. All of the exit signs should be replaced with LED type technology, which is very efficient, low on energy consumption and the LED lamps have a long life ~20,000 hours. A typical exit sign is shown in Figure 2-26.

9	Replace existing incandescent exit signs with new LED exit sign technology. Also, replace the two existing 'Stairway' signs and 'Deck' sign on the upper level with LED type and provide new wiring to all new fixtures.		\$3,000	
10	Replace the existing mercury vapor HID fixtures in the ice arena with new 6 lamp T-8 high bay fluorescent fixtures.		\$30,000	
11	Replace entire fire alarm system with AIA compliant addressable system.		\$75,000	
Electrical Costs Subtotal by Phase			\$164,000	\$185,000
Total Mechanical and Electrical Costs				
Mechanical and Electrical Subtotal			\$1,129,000	\$618,000
A/E Fee (10%)			\$112,900	\$61,800
Contingency (15%)			\$169,350	\$92,700
				\$0
Total Mechanical and Electrical Costs by Phase			\$1,411,250	\$772,500
				\$2,183,750

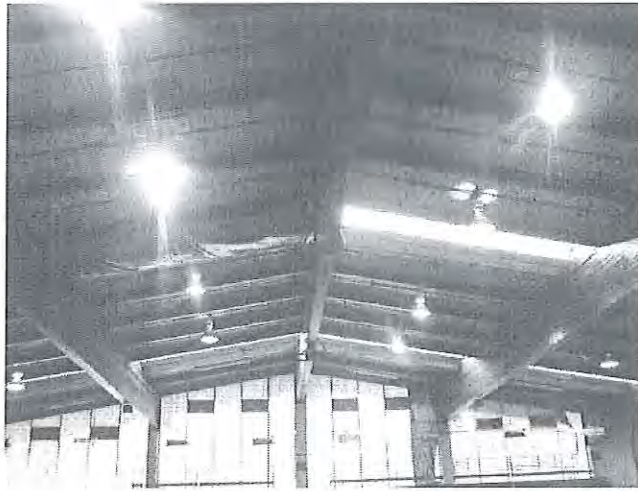
Figure 2-27: Ice Arena HID Lighting

The lighting in the ice arena consists thirty-six 1,000W mercury vapor lights (see Figure 2-27). *The lamps are energy inefficient and costly to operate. All of these lights are controlled by a switch control*

box located in the concession stand. These lights should be replaced with more efficient T-8 6-lamp high bay fixtures, which can be circuited for two or three levels of lighting for better lighting and energy savings. Table 4-3 shows that lighting systems survey.

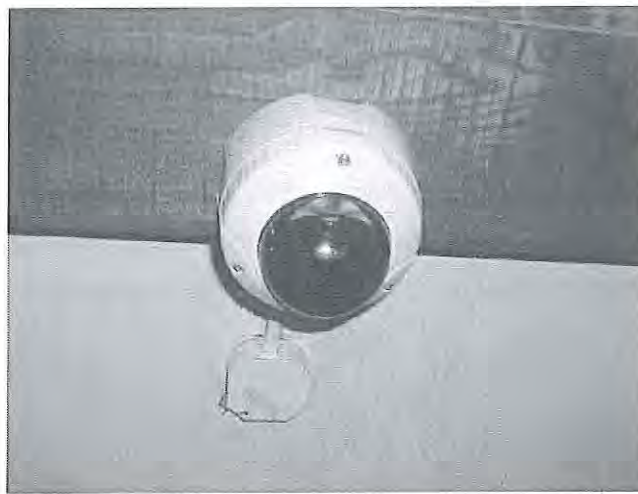
Figure 2-31: Security Camera

The security system in the building has three stationary color cameras, which are monitored by a closed circuit television in the lobby main office. The first camera is in the main entrance walkway, second camera on the left wall corner of main entrance walkway and the last camera is in the main lobby. The video fed from the cameras is recorded in the back main office. Also, all of the doors on the first floor, including the doors along the perimeter of the ice arena are all monitored by the security system. The security keypad will notify the user if any door is open. The security system is tied to the police department.

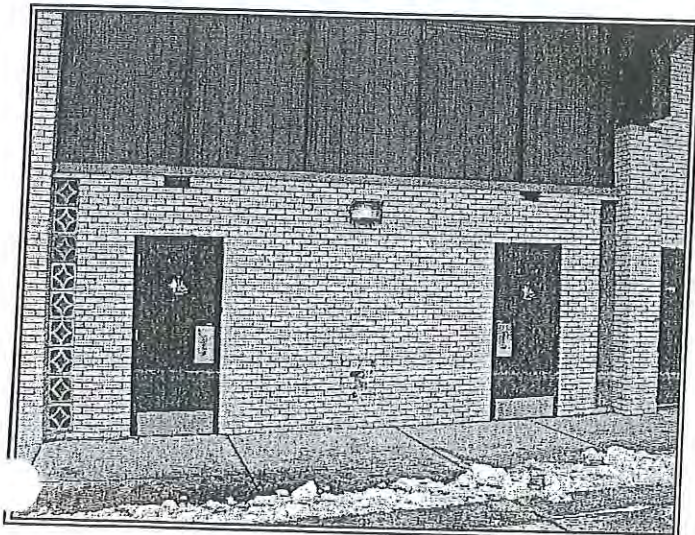
West wall of Ice Rink – Wood patch of wall

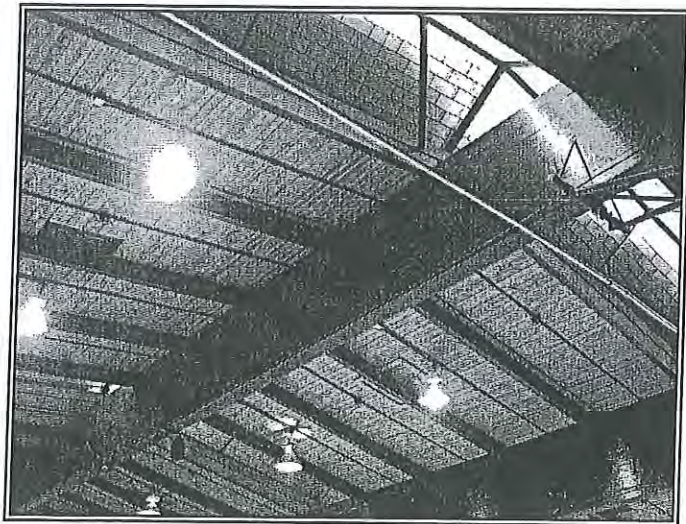
Ice Rink - Roof Structure & Skylight

Architectural and Structural Recommendations				
Architectural Recommendations				
1	Exterior: Repair brick columns at main entry, provide expansion joints and re-adjust paving around column bases.		\$6,000	
2	Exterior: Repair decorative masonry blocks at west wall (wood patch) of Ice Rink. Patch any holes and tuck point entire building.		\$5,000	
3	Exterior: Repair exposed laminated wood beams ends of Ice Rink enclosure - provide new copper caps at each beam.		\$11,000	
4	Exterior: Repair downspout drainage collection system at foundation walls of Ice Rink and pitch grade away from building.		\$5,000	
5	Exterior: Replace Adult Deck (2nd floor) surface and provide new insulation and waterproof membrane to eliminate leaks.		\$155,000	
6	Exterior: Replace existing roof over Constock Room - provide additional roof insulation - patch wood decking atleak.		\$45,000	
7	Exterior: Replace existing translucent (Kalwall) skylights over Ice Rink.		\$175,000

8	Exterior: Replace existing roof over Ice Rink - provide additional roof insulation and flashings.		\$660,000	
9	Exterior: Replace translucent (Kalwall) wall panels at west, south and east walls of Ice Rink enclosure.			\$140,000
10	Exterior: Replace windows in Men's and Women's locker rooms with thermally improved units.		\$10,000	
11	Lobby: Replace guardrail at floor level change and provide new handrails at stair and entrance ramp.			\$16,000
12	Lobby: Provide new suspended acoustical (impact resistant) ceilings and lighting design to update lobby appearance.			\$35,000
13	Handicap Accessible Toilet Rooms: New handicap accessible vanities, faucets, finishes and new suspended ceiling with lighting and exhaust system.			\$40,000
14	Lobby/Toilet Rooms: New handicap accessible vanities, faucets, finishes, new suspended ceiling with lighting and exhaust system and repair plumbing			\$35,000
15	Office: Separate Skate Rental office from registration office with partition, hollow metal door and frame.		\$5,000

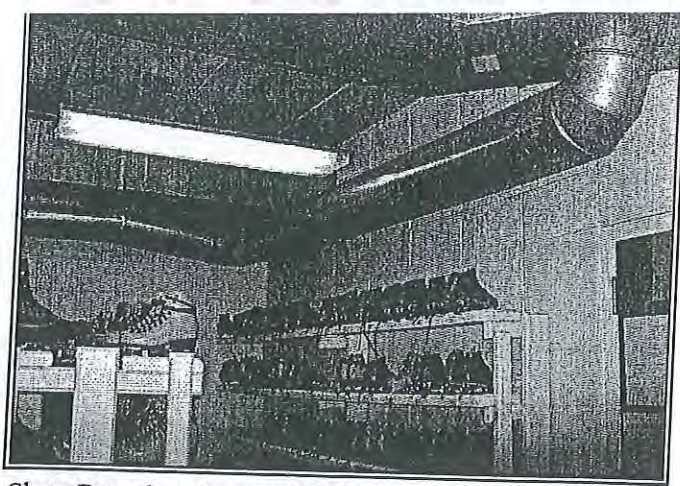
Skate Rentals – ductwork additions

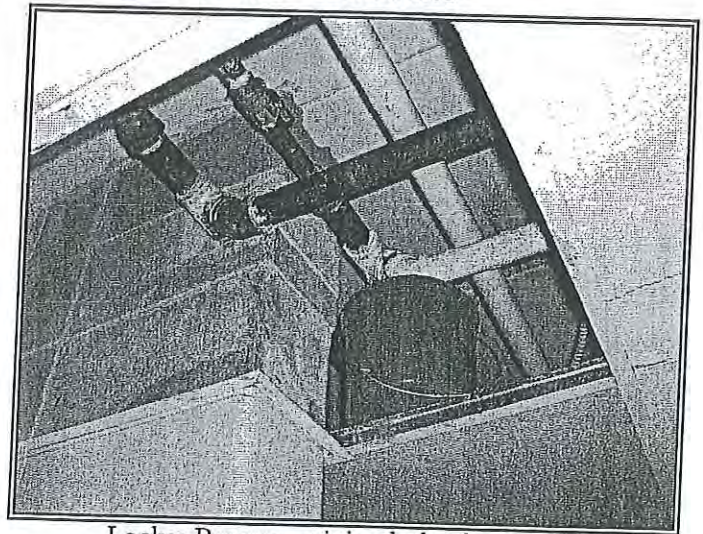
Locker Rooms – piping leaks above ceilings

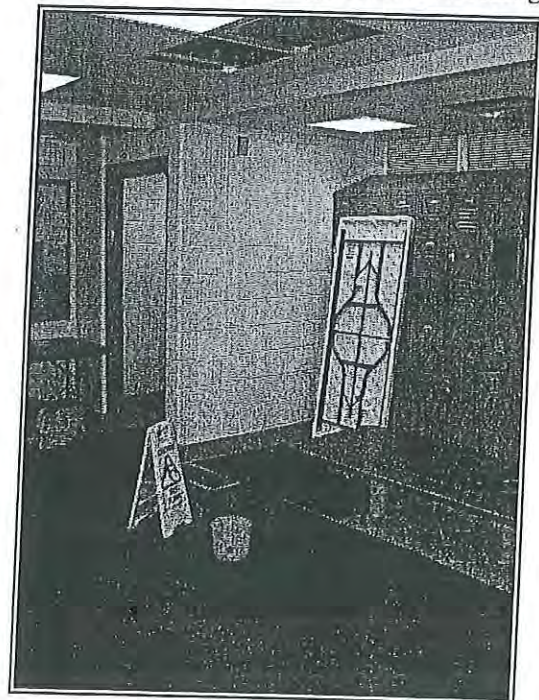
Locker Rooms – leak

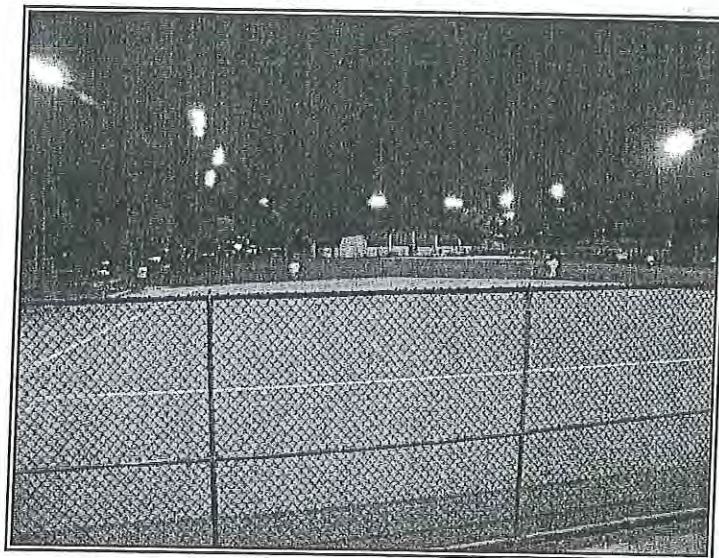
Ballfields – field lighting

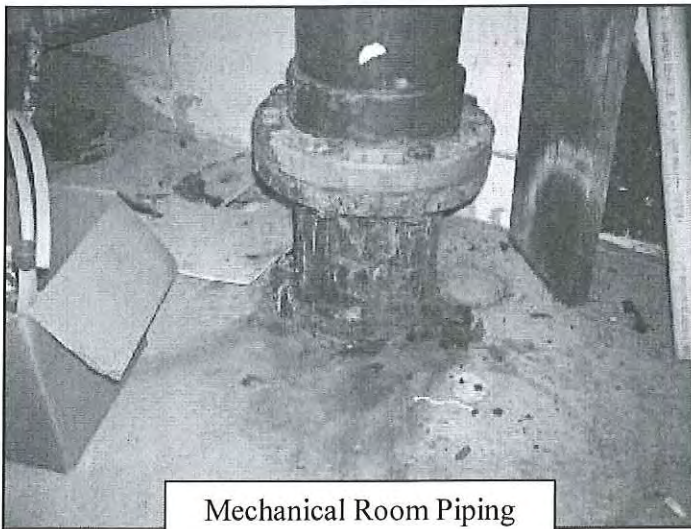
Mechanical Room Piping
