SERVICE BULLETIN No. 5

Tail Tray Reinforcement

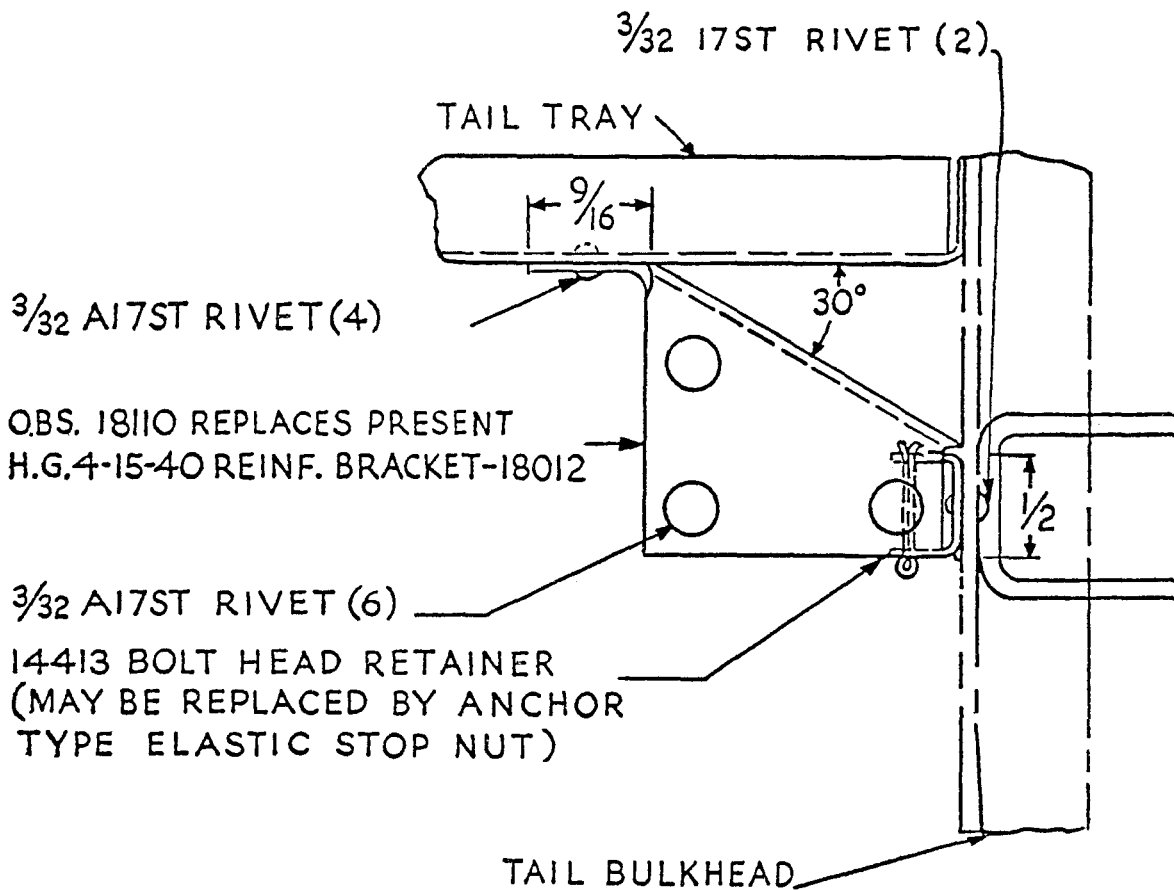
The tail tray is a horizontal bulkhead located in the tail of the fuselage just under the horizontal stabilizer. In two or three instances owners have reported cracks in this tray just forward of its at-

tachment to the rear bulkhead. The repair for such damage is shown on the sketch. It is recommended that you make the replacement shown on your airplane, whether or not cracks have yet developed.
