# SERVICE

NUMBER 91

SUBJECT: Inspection of Fuel Strainer Installation

MODELS AFFECTED: Piper J3C-65 Airplanes  
Serial Nos. 14027 through 17959

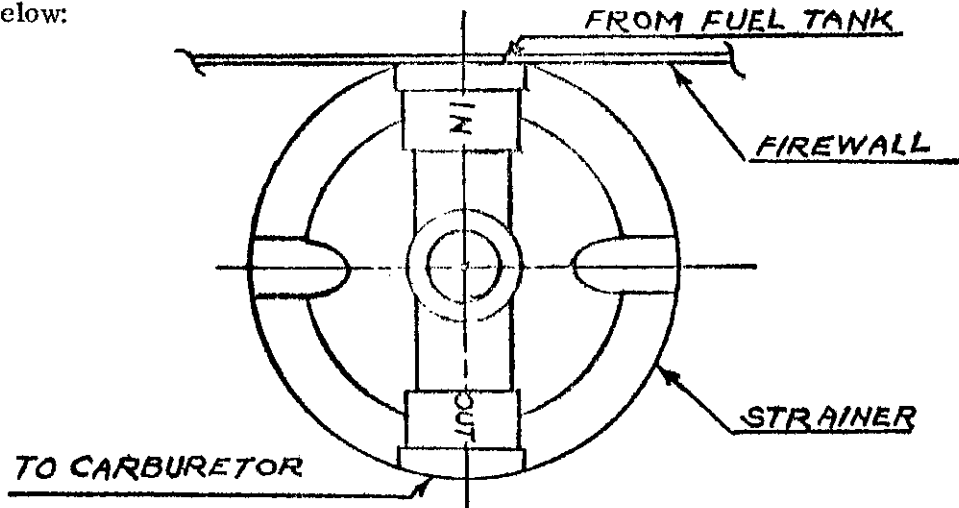
It has been brought to our attention that several J3C-65 airplanes have left the factory with the fuel strainer ports inadvertently reversed. Therefore, we are requesting that all owners inspect their airplanes for proper installation.

The ports are identified by the words "IN" and "OUT" in raised letters on the strainer cover. The proper installation and location of ports is shown below:

If the fuel strainer is not installed as indicated above, it should be reversed for proper fuel flow.

An appropriate entry should be made in the aircraft log book at the time this inspection is made.
