# SERVICE

# BULLETIN

Number 98

**SUBJECT:** Battery Insulator

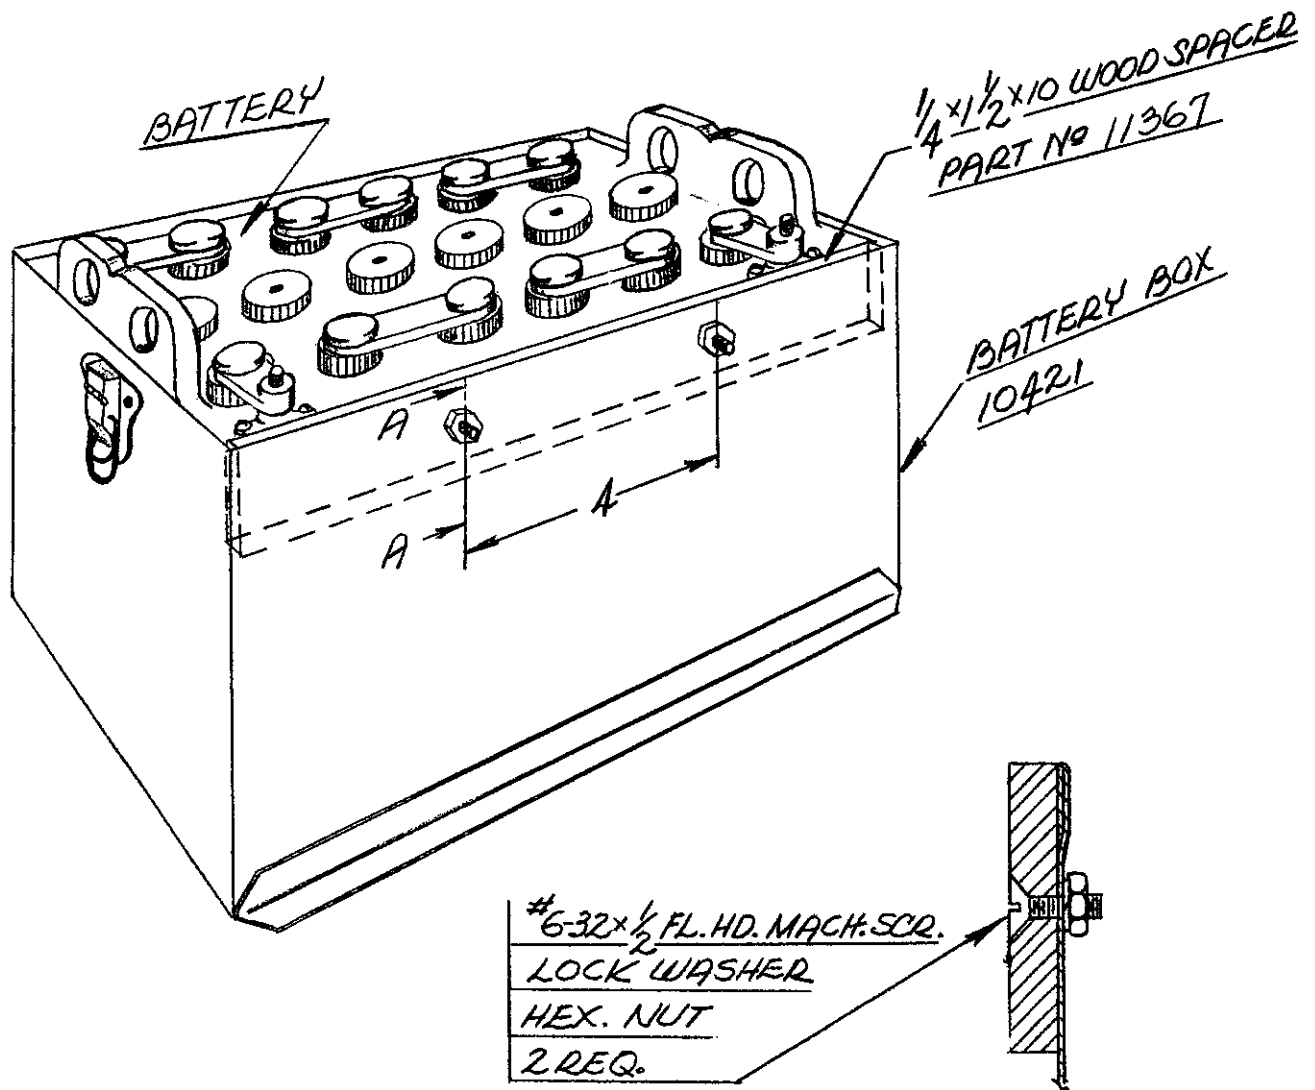
BATTERY SPACER INSTALLATION

It has been discovered that there is a possibility of a short circuit occurring between the battery terminal bases and the battery box on the above airplanes.

To eliminate this possibility, it is recommended that a strip of wood be fastened to the upper inside edge of the battery box (on the terminal side), as shown on the sketch on the opposite side of this bulletin.

If the Reading R24L Battery has been replaced with an S24 Battery, and the proper spacer channels, Part No. 10926 and 10927, installed, it will not be necessary to add the wood strip.

An appropriate entry should be made in the aircraft log book upon the completion of this change.
