Subject
Blowdown Cap Operation and Troubleshooting

UNDERHOOD® VR70 & DTM	UNDERHOOD VR150	Hydraulic Driven (Predatair)
Blowdown Cap P/N# 9200437	Blowdown Cap P/N# 9210028	Blowdown Cap P/N# 9400059

Document	Version	Department	Revision Details	Revised by	Tech	Engineering	Implemented
EXT-ALL-006	C	Tech	Syst update, format	BDJ 2 Apr.2024	N/A	N/A	11 Sept.2018

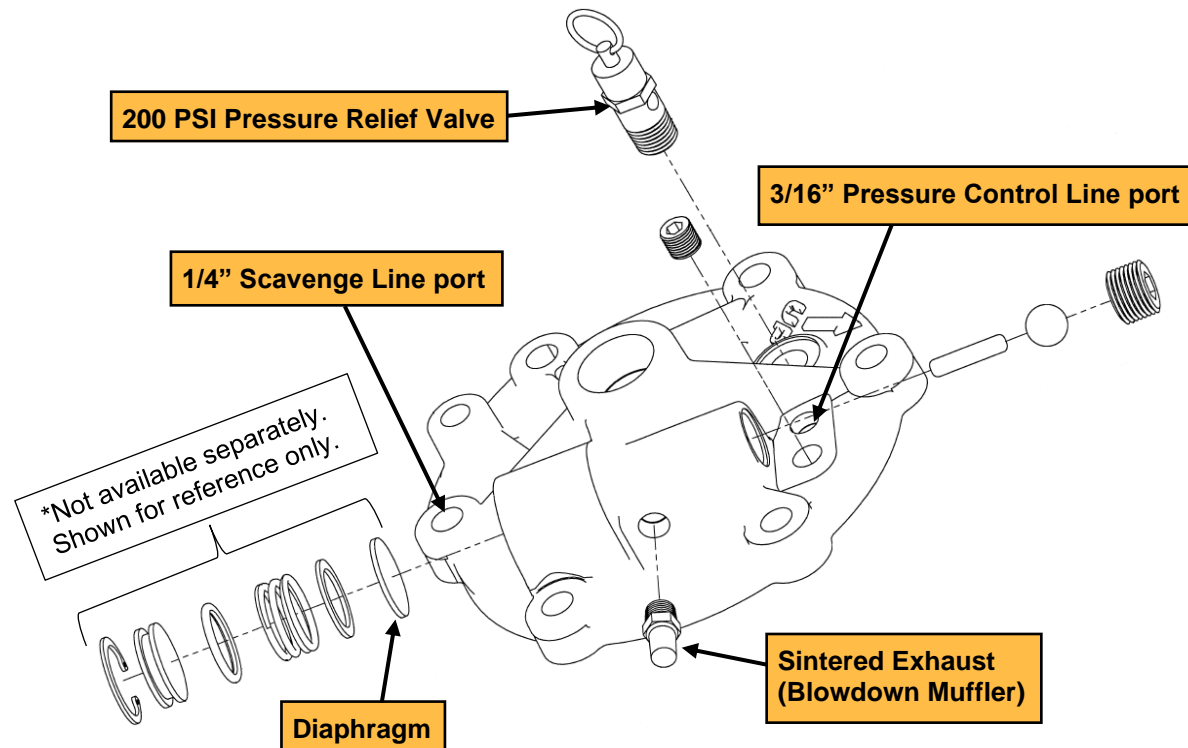
Figure 3 – Blowdown cap components

- Oil escaping through the sintered muffler.
- Premature clutch wear.
- Blowdown does not vent after compressor shut down.
- Blowdown constantly venting during compressor operation.
- System takes a long time to blow down.

- Determine if venting air is from the Blowdown Muffler or the 200PSI Pressure Relief Valve.
- Check the 1/4" scavenge line for leaks, kinks or obstructions.
- Check 1/4" scavenge fittings for leaks, or obstructions.
- Inspect the scavenge port in the blowdown cap. Ensure it is not obstructed.
- Ensure the scavenge screen is not plugged.

- Plugged muffler: This will prevent the air pressure from venting.
- Ball seized onto seat: Remove cap from tank, and shake the cap. The ball move should move freely inside, like in a paint can.

- Blowdown diaphragm* is damaged.
- Tank or cap mounted is upside down (Arrow on discharge cap should be pointing upwards).

- Restricted Blowdown muffler.
- External receiver tank installed without a one-way check valve between the AOST and the tank.
