Blowdown Cap Operation and Troubleshooting

<b>Underhood VR70 and DTM</b>
Blowdown Cap P/N# 9200437

<b>Underhood VR150</b>
Blowdown Cap P/N# 9210028

<b>PREDATAIR</b>
Blowdown Cap P/N# 9400059

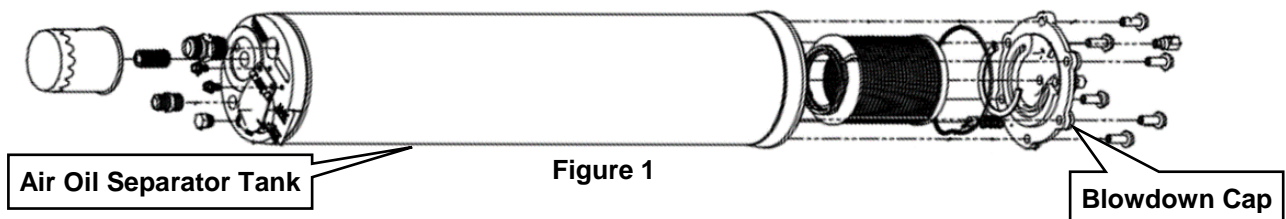
- **200 PSI Pressure Relief Valve:** a safety valve, used to protect the system from over pressurizing resulting in damaged components or tools.
- **Blowdown Muffler:** Diffuses blowdown air and lowers the noise level when the system depressurizes.
- **3/16" Pressure Control Line:** Supplies system air pressure to the regulator in the inlet.
- **1/4" Scavenge Line:** Used to route scavenged oil from the "dry side" of the AOST back to the compressor.

**If the system is equipped with Pressure Control and Scavenge lines that are constructed of braided rubber and steel, part number A700153 PTFE Tube retrofit kit will be needed when replacing a Blowdown Cap.**
