VSP-30
May 20, 1981

VENDOR SERVICE PUBLICATION

Subject: Bendix Service Bulletins 599A, 609A, 610,
613, 614

SERVICE BULLETIN NO. 599A
(Supersedes Service Bulletin No. 599)
Engineering Aspects are
FAA Approved

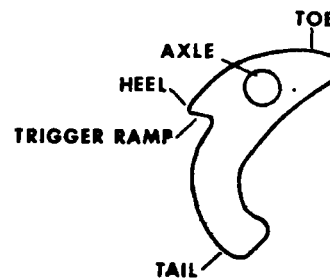
Figure 1. Terminology

- a. Bend the end of a stiff wire into a right angle 1/8 inch long, maximum.
- b. Position impulse coupling so that heel of flyweight (see figure 1) is adjacent to stop pin. Reach

between cam and flyweight with bent wire, as near as possible to the stop pin, and pull outward on the flyweight as shown in figure 2.

d. If less than 0.017 inch clearance exists, this is cause for immediate rejection of the impulse coupling cam assembly, or possibly the entire impulse coupling. Refer to the applicable Magneto Overhaul Instructions for inspection procedures to determine if other impulse coupling parts are still serviceable.

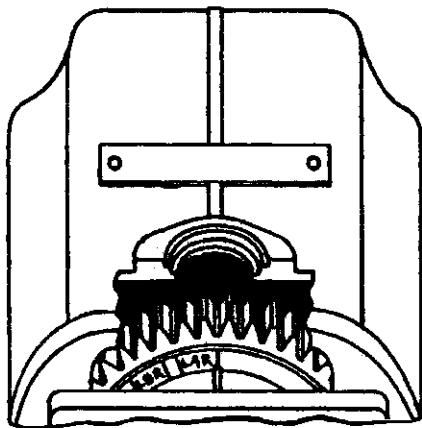
Figure 2. Alignment of Timing Marks on Distributor Gear – 4 Cylinder, Right Hand Rotation

- a. Turn engine in direction of normal rotation past TDC firing position until impulse coupling "clicks."
 - b. Turn engine in opposite direction slightly past the TDC firing position.
 - c. Turn engine slowly back toward number one cylinder firing position until proper timing mark on magnet is in center of the viewing hole (See figure 1).
4. Check at top timing hole in magneto to determine if proper mark on distributor gear aligns with timing rib on distributor block. Alignment tolerances are as follows:
- a. "4" and "8" Cylinder, all types – The timing rib on the distributor block MUST align within 1/2 tooth either side of the "L" or "R" mark on the gear, depending on magneto rotation. (See figure 2)

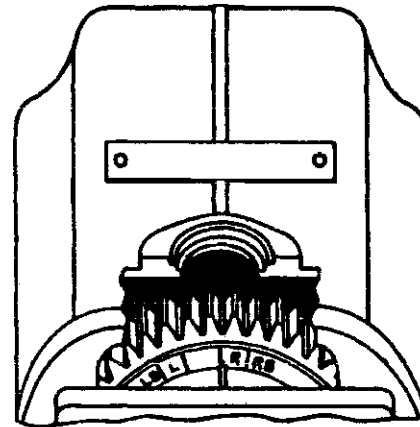
Figure 3. Alignment of Timing Marks on Distributor Gear – 6 Cylinder, Single Breaker, Right Hand Rotation

- b. "6" Cylinder, single breaker types – The timing rib on the distributor block MUST lie between the "L" and "LB" or the "R" and "RB" marks on the gear, and should be nearer to the "L" or "R" mark, depending on magneto rotation. (See figure 3)

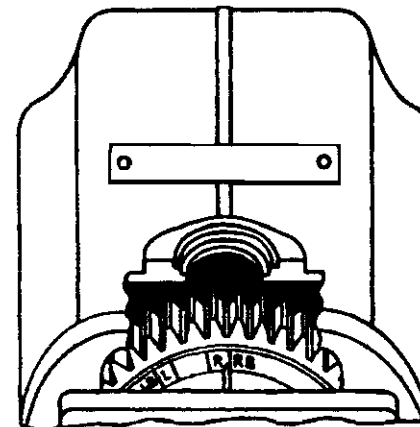
Figure 4. Alignment of Timing Mark on Distributor Gear – 6 Cylinder, Retard Breaker, Right Hand Rotation

- c. "6" Cylinder, retard breaker types – The timing rib on distributor block MUST lie between the "L" and "LB" or the "R" and "RB" marks on the gear, and should be nearer to the "LB" or "RB" mark, depending on magneto rotation. (See figure 4)

7. If timing marks are not aligned remove magneto from engine and follow instructions in Method "B".

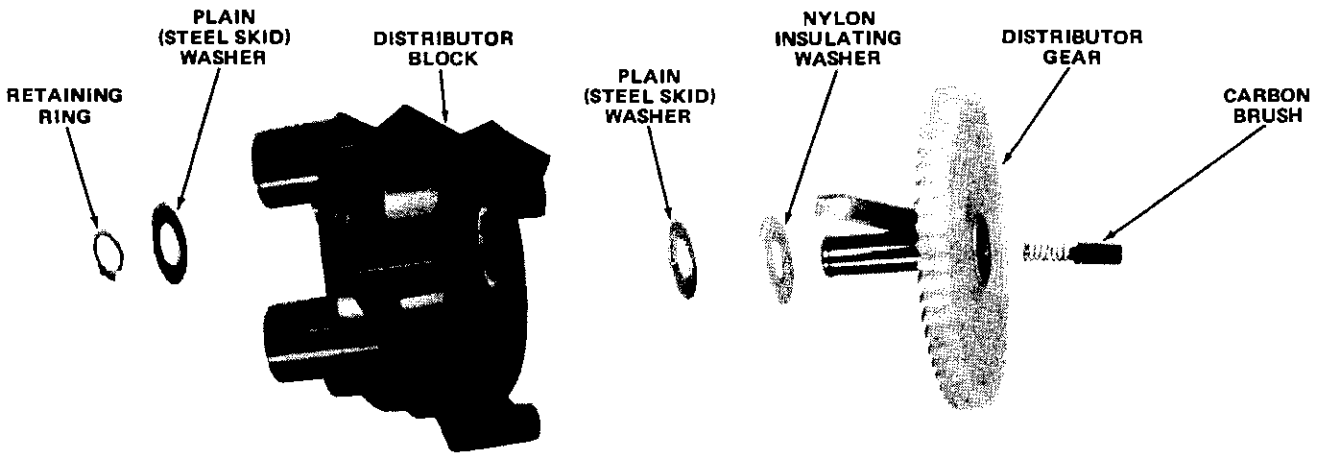
This bulletin announces availability of an improved, insulated distributor gear in kit form which is interchangeable between the D-2000/D-2200 & D-3000/D-3200 series magnetos. The kit includes all parts (except distributor block) as identified in figure 1.

Assembly sequence of the gear kit to distributor block is shown in Figure 1.

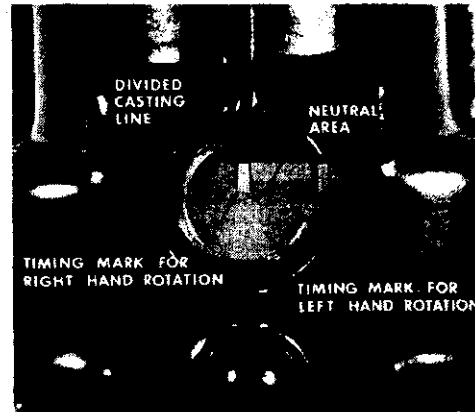
Figure 2. Alignment of Magnet Marks — Right Hand Rotation

- b. Continue turning the engine slowly, still in the direction of normal rotation, until the proper timing mark on the rotating magnet is centered in the viewing hole. Figure 2 illustrates the timing mark centered for a right hand rotation magneto. A left hand rotation magneto would have the left hand mark centered. (See figure 2.) Eight cylinder magnetos will show an "R" line or an "L" line on the rotating magnet.

one cylinder firing position until proper timing mark on rotating magnet is in the center of the viewing hole. (See figure 2.)

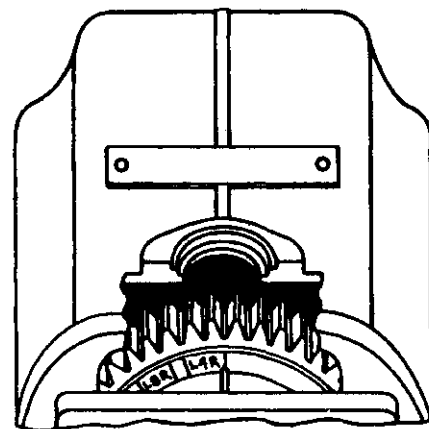
Figure 3. Alignment of Timing Marks on Distributor Gear — 4 Cylinder, Right Hand Rotation

6. Check at top timing hole in magneto to determine if the proper mark on the distributor gear aligns with the timing rib on the distributor block. Alignment tolerances are as follows:
 - a. Four and eight cylinder, all types — The timing rib on the distributor block **MUST** align within 1/2 tooth either side of the "L" or "R" mark on the gear, depending on magneto rotation. (See figure 3.)

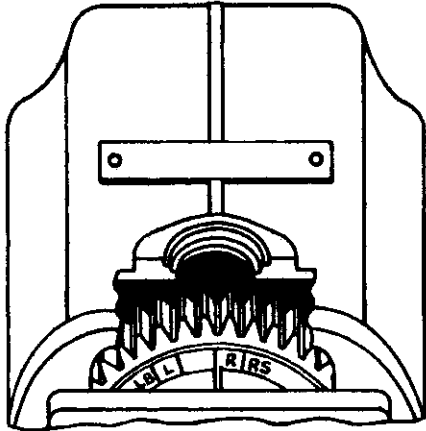
Figure 4. Alignment of Timing Marks on Distributor Gear – 6 Cylinder, Single Breaker, Right Hand Rotation

b. Six cylinder, single breaker types – The timing rib on the distributor block MUST lie between the "L" and "LB" or the "R" and "RB" marks on the gear, and should be nearer to the "L" or "R" mark, depending on magneto rotation. See figure 4.

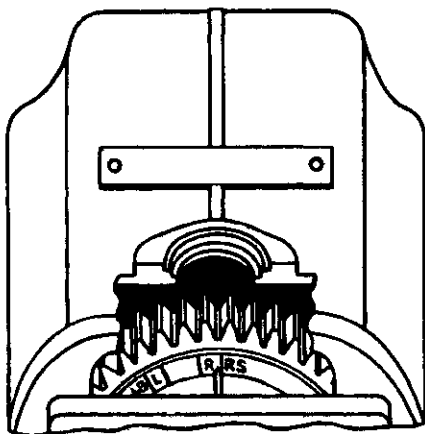
Figure 5. Alignment of Timing Marks on Distributor Gear – 6 Cylinder, Retard Breaker. Right Hand Rotation

c. Six cylinder, retard breaker types – The timing rib on the distributor block MUST lie between the "L" and "LB" or the "R" and "RB" marks on the gear, and should be nearer to the "LB" or "RB" mark, depending on magneto rotation. (See figure 5.)
