SERVICE BULLETIN

No. 354B

Piper Aircraft Corporation

Subject: Fuel Selector Valve Lubrication

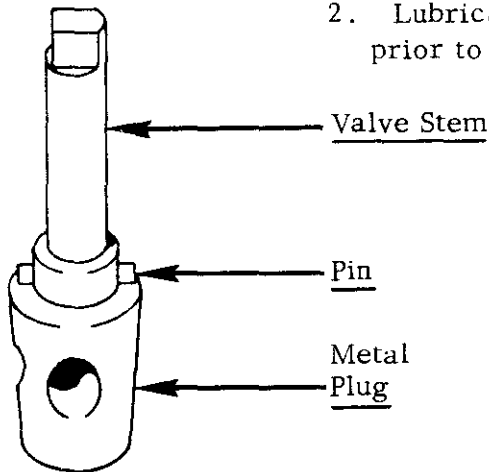
Position Washer
1. Check inside perimeter for indication of extreme wear; if wear is readily apparent, replace position washer.
2. Lubricate with MIL-G-6032 (Type I) prior to reinstallation.

Check ports for cracks; if cracks are evident, replace valve. Remove excess grease from ports prior to reinstallation.

3. Check condition of plug and valve body for scored surfaces. The surfaces, if not badly scored, may be conditioned by lapping with a fine grinding compound. Clean away all compound after lapping. If plug will not seat properly or if scoring remains evident, replace valve with Valve Replacement Kit 764 295.

4. Check condition of valve stem in the area where the "O" ring seats. Should the stem be worn or damaged so that the "O" Ring will not seal, replace valve with Valve Replacement Kit 764 295.

5. With a 10x magnifying glass, inspect valve ports for cracks; if cracks are visible, replace valve with Valve Replacement Kit 764 295.
