SERVICE BULLETIN

Ercoupe

No. **105** Date July 1, 1959

Subject: Rudder — Modification of

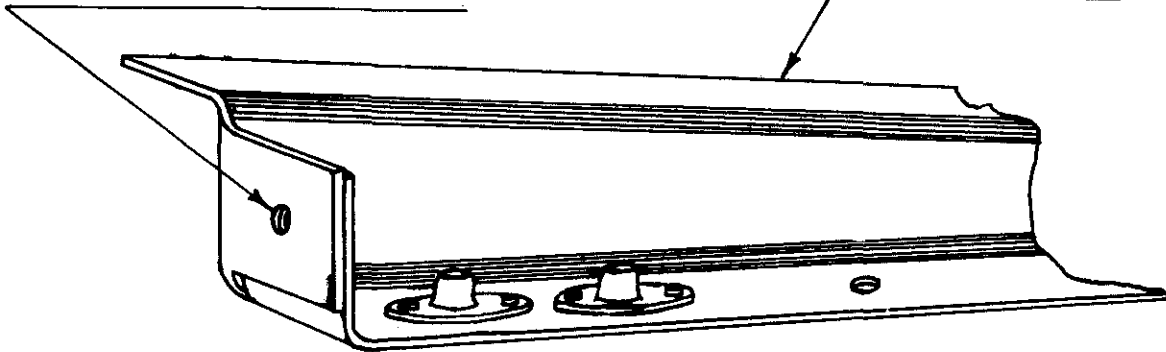
FIG. 1

HOLE "A"
DRILL THROUGH #40

F-24015 RIB

RIGHT-HAND RIB SHOWN
LEFT-HAND RIB OPPOSITE

DETAIL SHOWING POSITION FOR DRILLED HOLE "A" IN RIB ASSEMBLY

- (a) Back drill #40 hole, "A", at nut plate end of new rib (F-24015), as illustrated in Figure 1.
- (b) It is necessary to trim the stiffener located at the bottom end of the rudder outboard skin as noted in Figure 2. (Note illustrations and procedure before trimming the stiffener.)
 - (1) To trim the stiffener for clearance, it is suggested that four rivets, at the end to be trimmed, be removed.
 - (2) The rib can now be trimmed as shown in Figure 3.

(c) Drill #40 hole through rudder spar by back-drilling through pilot hole "A" in new rib, (nut plate end.)

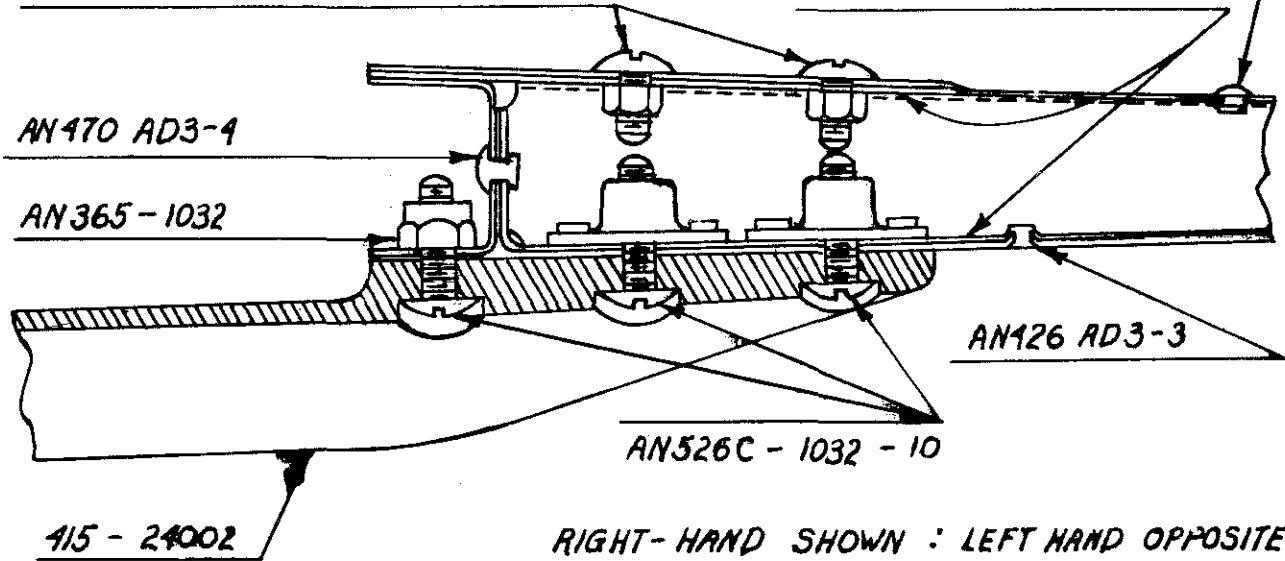
FIG. 4

COVER HOLES IN OUTBOARD SKIN
AN365 - 632 NUT
AN515 - 6-6 SCREW

DUPONT #DR-134A-6
EXPLOSIVE RIVET

REINFORCEMENT PLATE
415 - 24007

RIGHT-HAND SHOWN : LEFT HAND OPPOSITE

DETAIL SHOWING LOCATION OF HOLES TO BE FILLED IN OUTER SKIN

(a) If the rudders were modified per the previous Ercoupe Service Bulletin No. 23, there will be two holes in the outboard skin where the attaching screws of the control horn protruded. To cover these holes, use the two screws (AN 515-6-6) and nuts (AN 365-632) as noted in Figure 4. (Note: If "T" shaped reinforcement was installed in accordance with the previous service bulletin, it may be used for additional strength by attaching it to the outboard skin with the screws used to cover the open holes, or it may be omitted.)

(e) Install the rudder control horn with AN 526C-1032-10 screws, as shown in Figure 4.
