# SERVICE

# BULLETIN

NUMBER 181

SUBJECT: Replacement of 1/8 - 7 x 19 Flexible Stainless Steel Control Cables

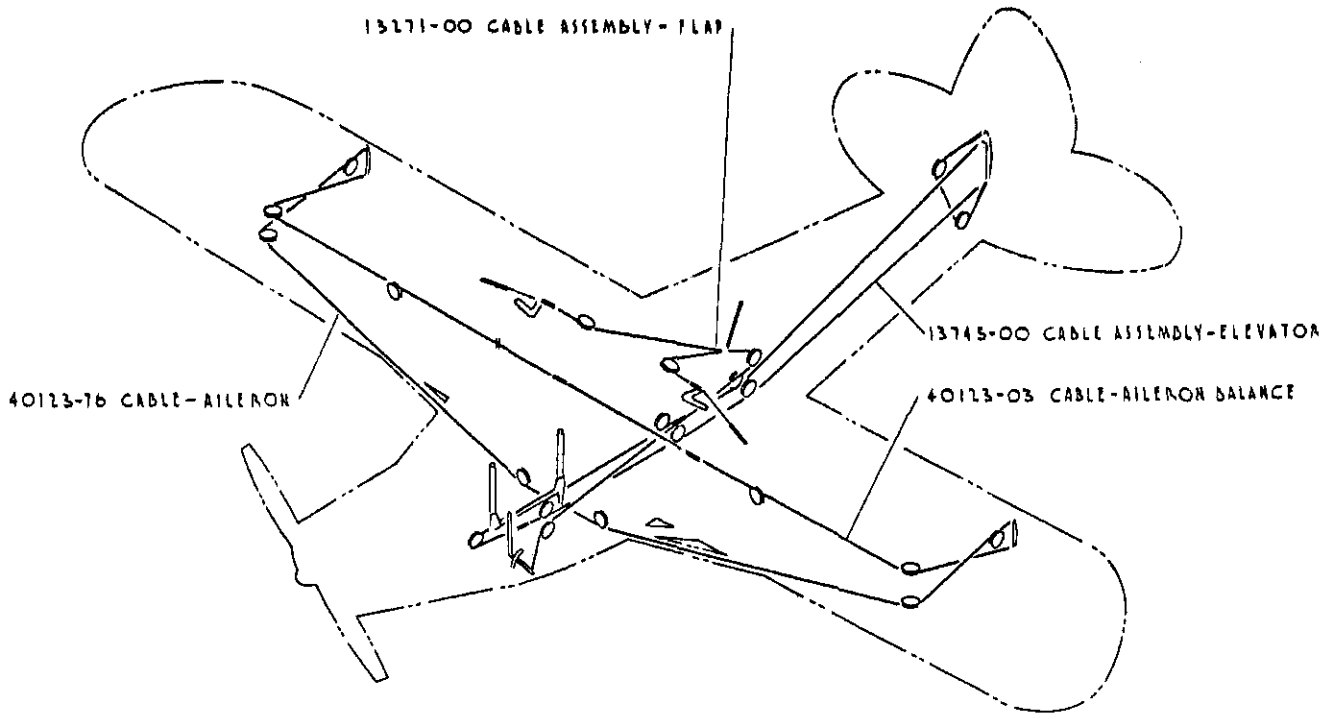
PA-18A

The following is a list of the affected control cables and their respective replacement parts which apply to the aircraft serial numbers listed after "MODELS AFFECTED", exclusive of the aircraft listed under Note "A". See sketches A, B and C for identification.
