Service Letter No. 136A

TO: Owners of PA-20 and PA-22 Airplanes with serial numbers
20-1 through 20-923 and 22-1 through 22-775

SUBJECT: Chafing of Fuel Line and Fuel Valve Operation

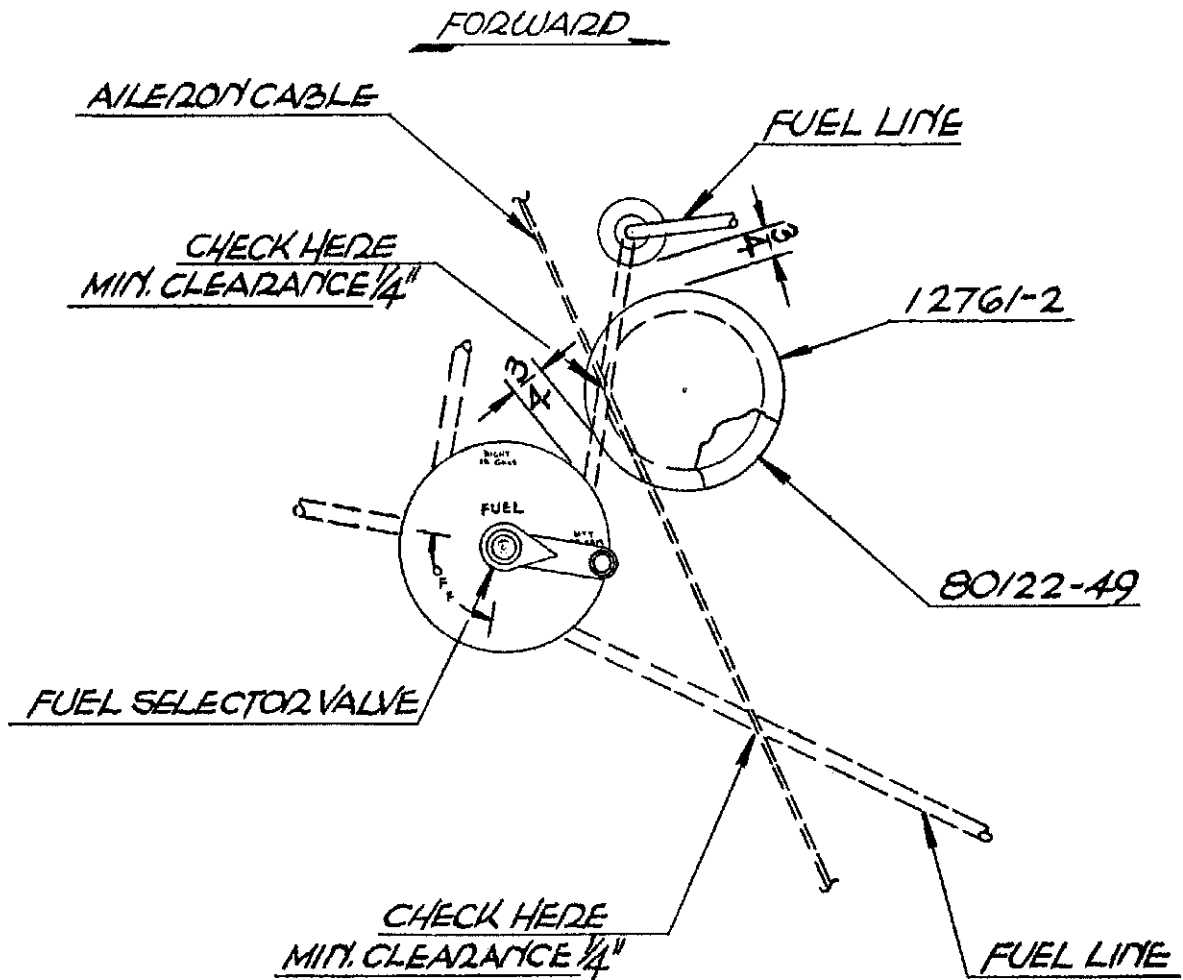
Sketch for Service Letter No. 136A

To accomplish this, dope the pyralin grommet, 80122-49, to the fabric inside the cabin as shown in the sketch. Cut away the fabric enclosed within the grommet.

Upon completion, install the cover, 12761-02, as shown in the sketch.

VIEW OF LEFT SIDE FROM INSIDE CABIN

Inspect the fuel lines for evidence of chafing by the aileron control cable. Check the clearance between the fuel lines and the cable. If 1/4" or more clearance exists no further action is required. If 1/4" minimum clearance has not been provided, form the fuel lines by hand to obtain this minimum clearance. Exercise care while forming to avoid crushing or kinking the fuel lines.

Further inspect the main fuel line for clearance at the rudder pedal torque tube arm. This inspection may be accomplished through the existing opening in the fabric. If adequate clearance is not provided, form the fuel line in the manner indicated above.
